Inspected By: Timothy Moreau, P.E.

Home Inspection Report

45 Oak Run Drive

Inspected on Fri, Sep 6 2019 at 2:00 PM

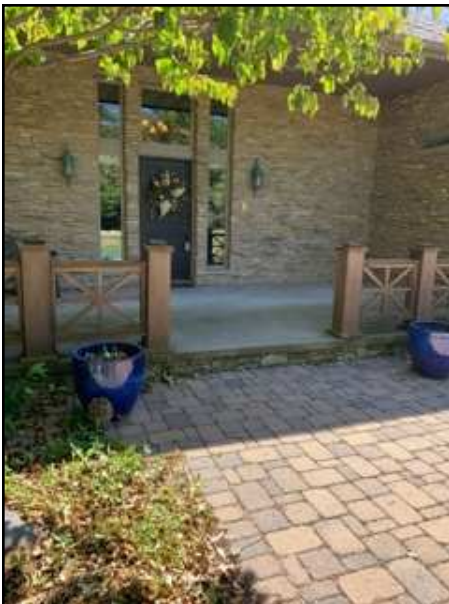
Figure 6-1

Front Entry Stoop.

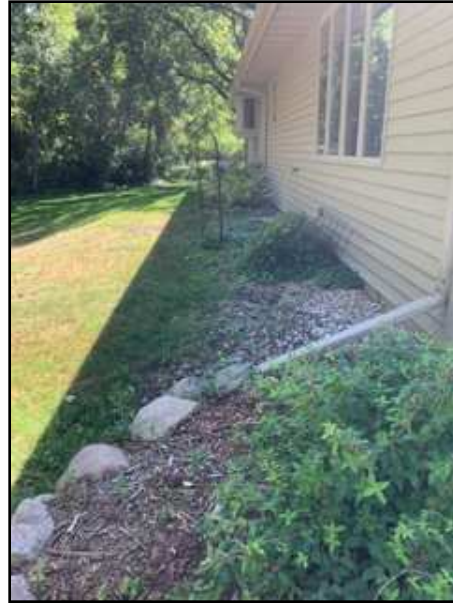
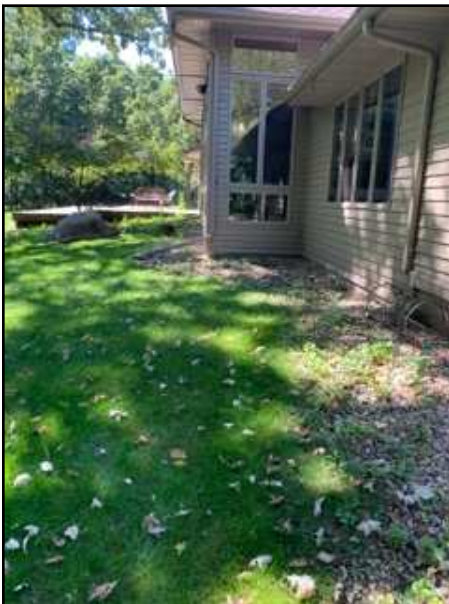
Comment 7:
Planting Area Overgrown with Weeds.

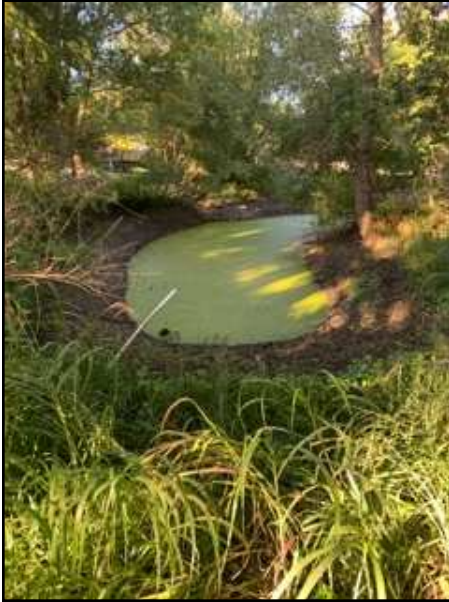
Figure 10-1

Water Level in Pond Located to the East Estimated to be 4' below Floor Level of Crawl Space at Time of Inspection.

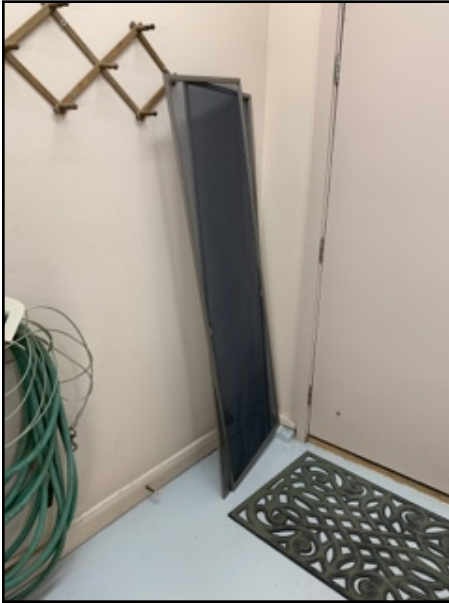
Figure 15-1

**Comment 15:**
A number of the Window Screens have been removed from Windows.

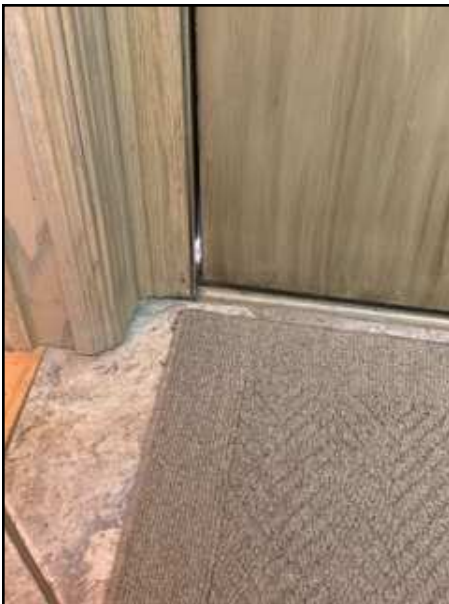
Figure 19-1

Door No. 3 - Air Gap Lower Left Corner; Weather Stripping Does Not Extend all the way to bottom of Door Jamb

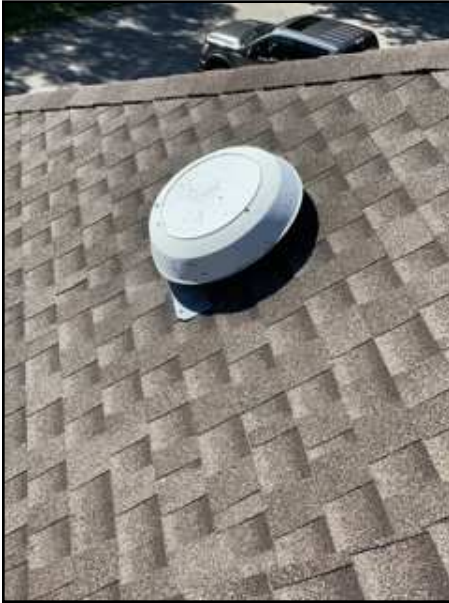
Figure 22-1

Comment 22:
Power Roof Ventilator.

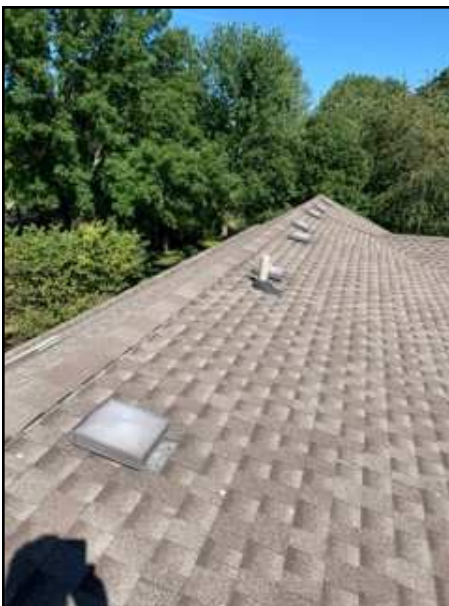
Figure 23-1

Comment 23:
Roof Ventilators - 10 each.

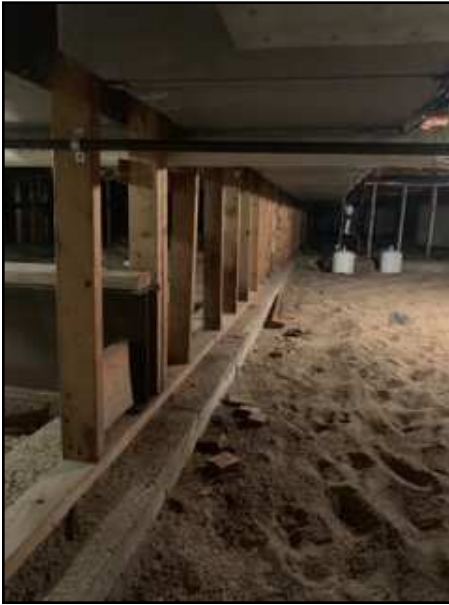
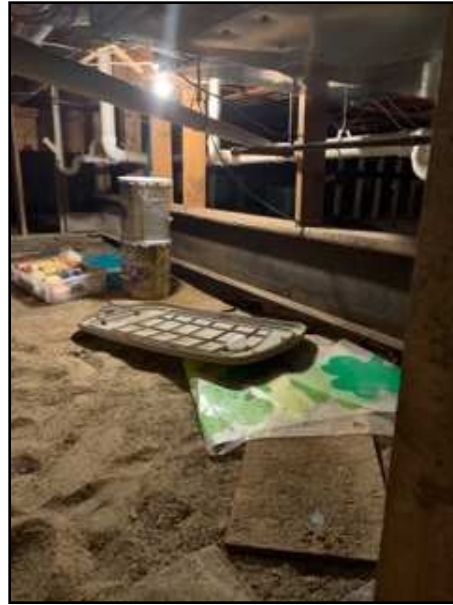
Comment 26:
Crawl Space Wood Support Partition Bearing on PCC Footing; 14" I-Beam Supporting Bearing Wall Above.

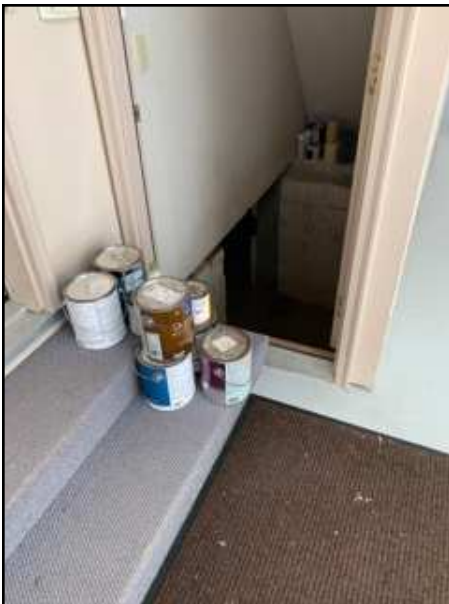
Figure 27-1

Comment 27:
Awkward Access to Crawl Space .

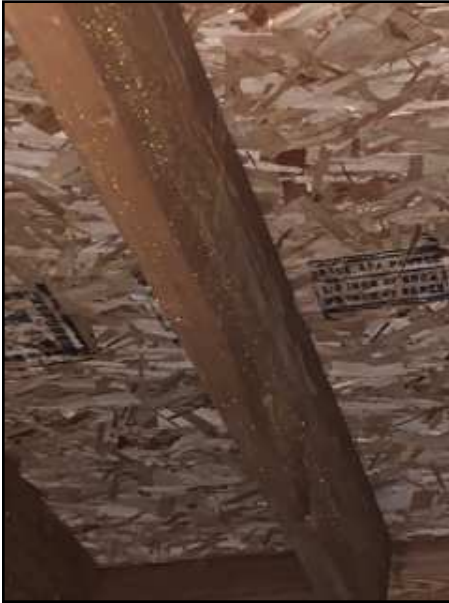
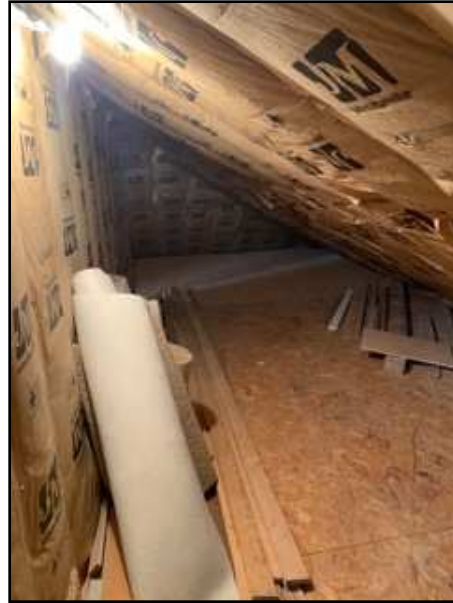
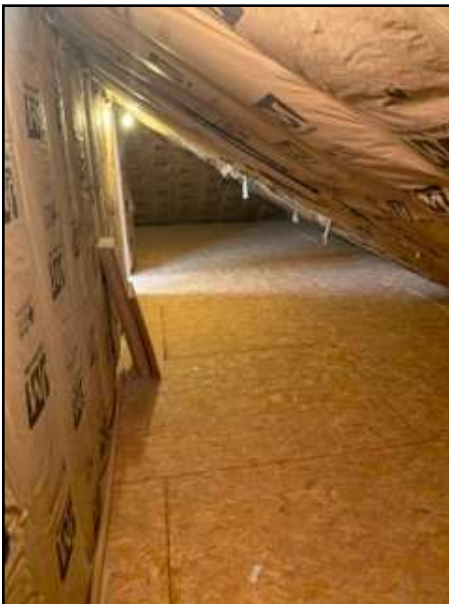
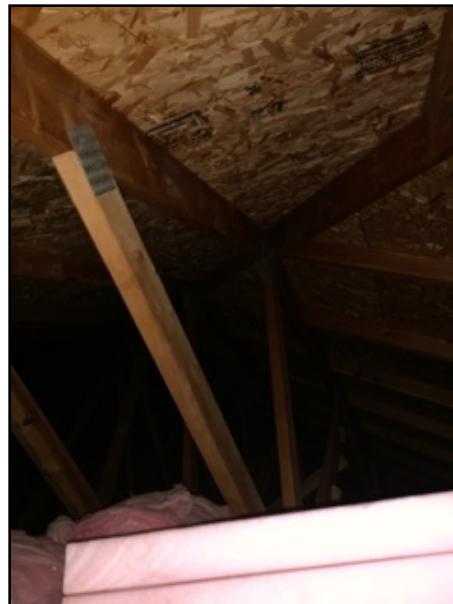
Comment 33:
Roof Framing / Attic Area.

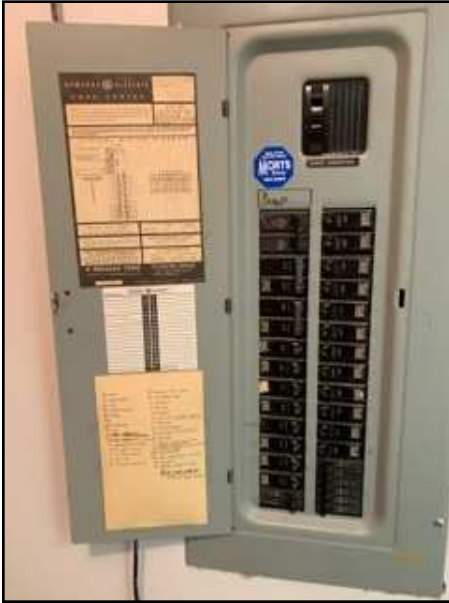
Figure 34-1

Comment 34:
Main Electric Service Panel.

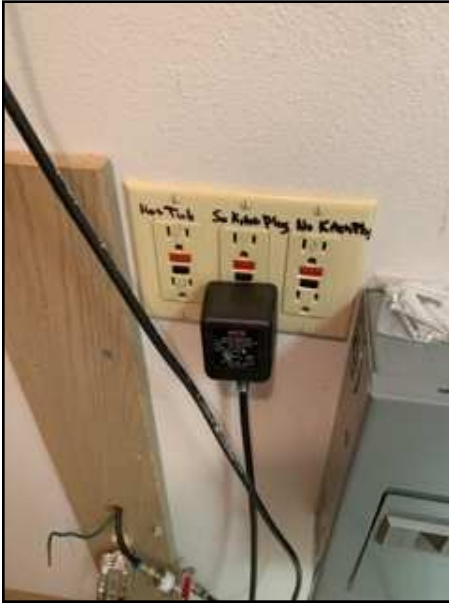
Figure 36-1

**Comment 36:**
GFIC Breakers for Kitchen Sink Area & Hot Tub Located in Utility Room.

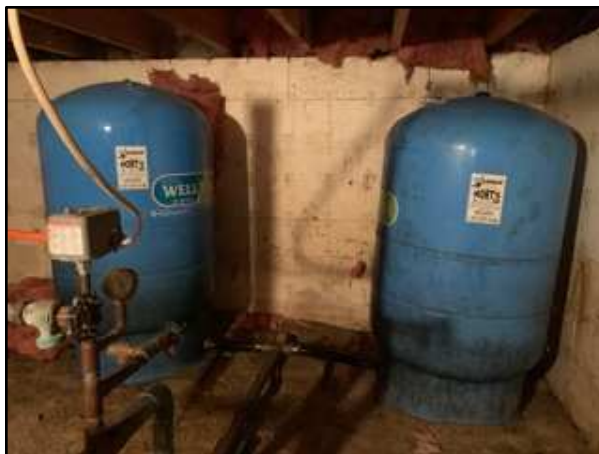
Pressure Tanks in Crawl Space - 50 Gallon Capacity per Tank Estimated;
Pressure Switch Set at 40 psi On / 60 psi Off.

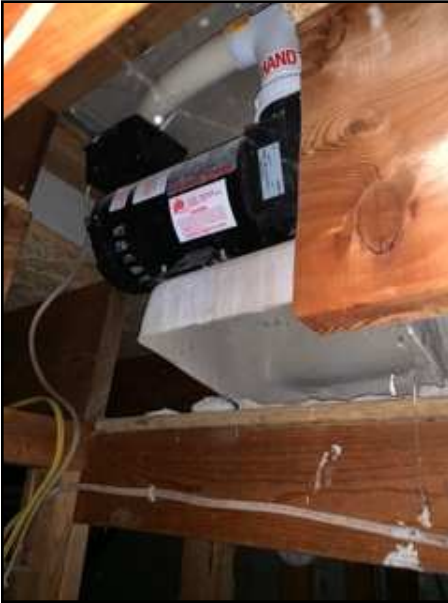
Figure 51-1

Comment 51:
Motor & Pump for Hot Tub.

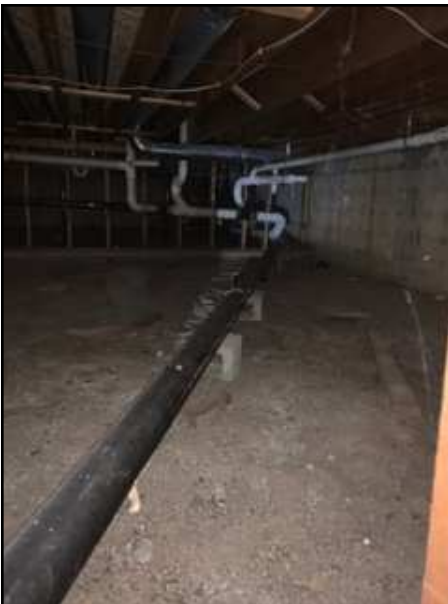
Figure 52-1

Comment 52:
Wastewater Drain Piping on East if Dwelling.

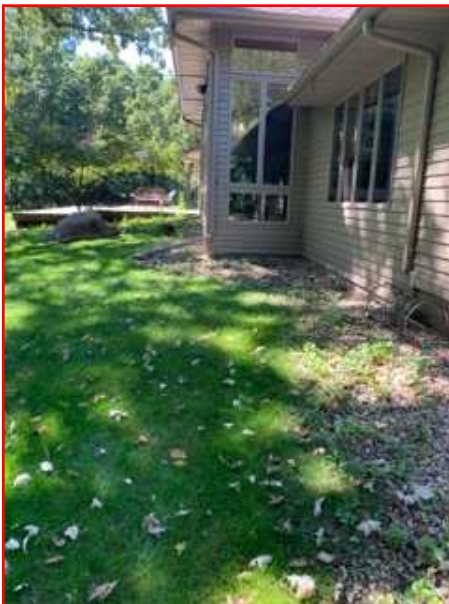
4) Comment 7: Planting Area Overgrown with Weeds.

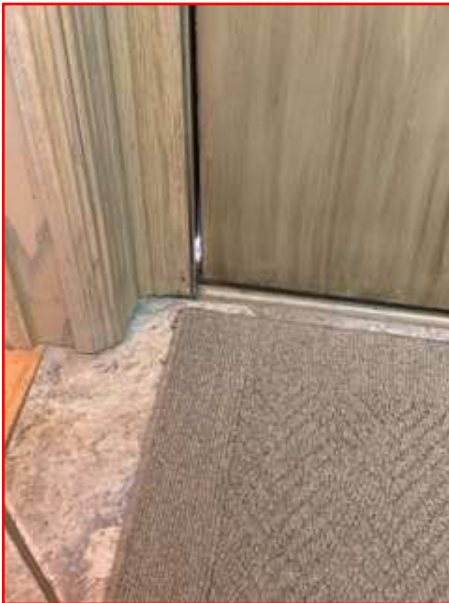
Figure 19-1

11) Comment 19: Door No. 3 - Air Gap Lower Left Corner; Weather Stripping Does Not Extend all the way to bottom of Door Jamb

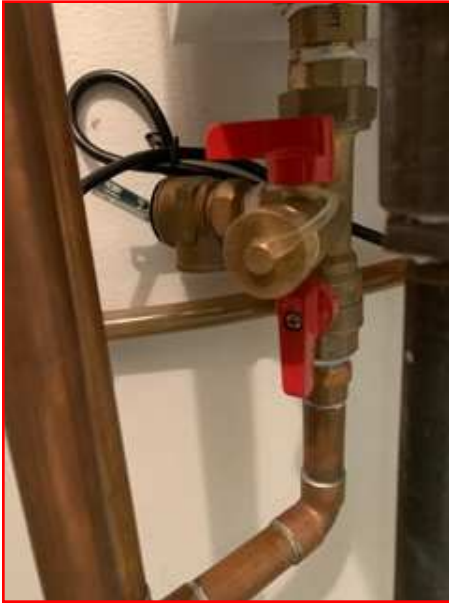
Figure 54-1

25) Comment 54: Pressure Relief Valve - No Discharge Piping.

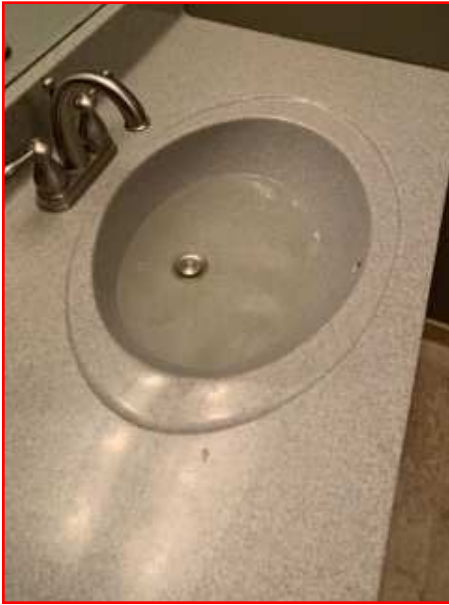
Figure 58-1

29) Comment 58: Sink Slow to Drain / Ran Hot Water for 3 - 4 minutes and water never got warm.
