FULL RESERVE STUDY

Victorian Condominium Association

Cleveland Heights, Ohio
August 23, 2018

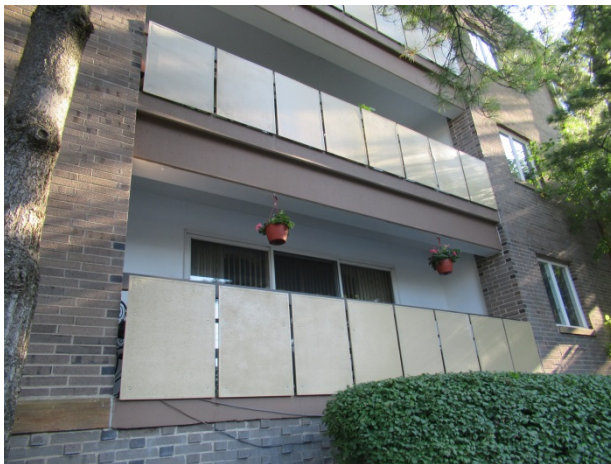
Condition: Good to fair with areas of spalled concrete and minor efflorescence present

Typical balconies

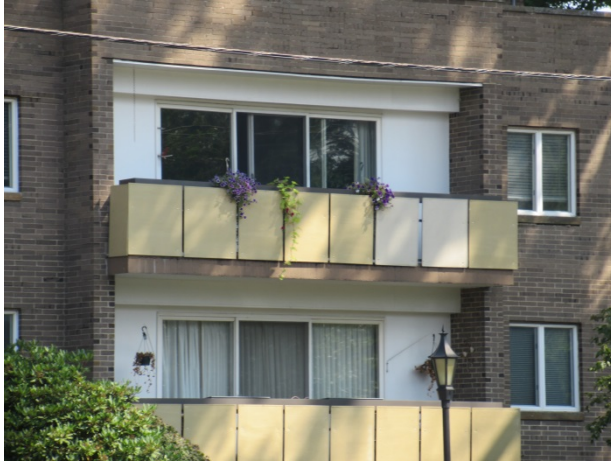
Conditions: The railings are in good to fair condition and the railing finishes are in good condition. The railings exhibit isolated panel rust.

Railing panels

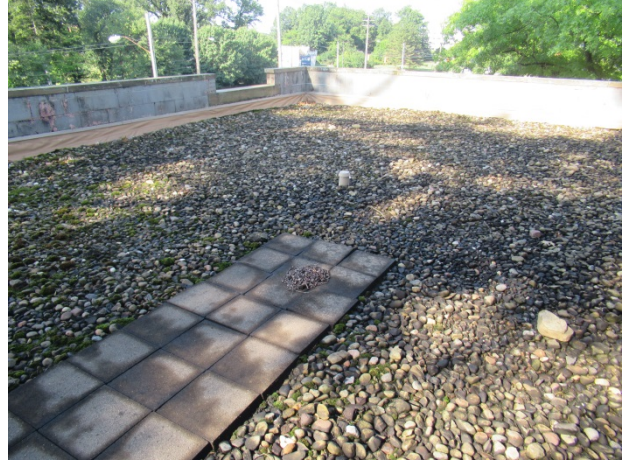
Built-up roof section

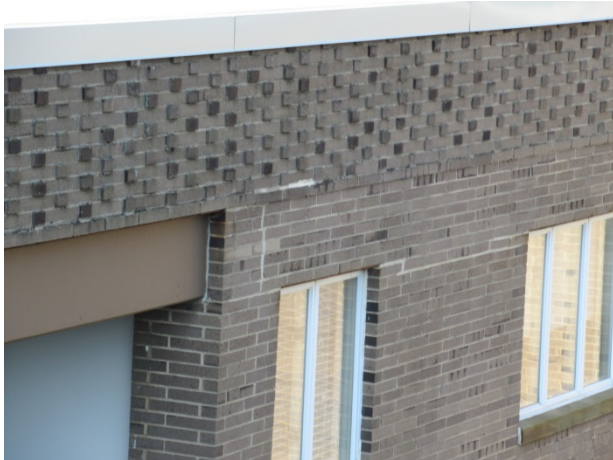
- Previous repairs evident
- Lintels exhibit rust
- Masonry exhibits cracks, particularly adjacent to balconies and at the base of the walls
- Masonry exhibits spalls at stone near balconies
- Mortar loss is evident at lintels and below sills
- Stains are present
- Mortar joints are tooled
- Weeps and flashing at lintels are not visible
- Sealant failure is typical

Previous repairs

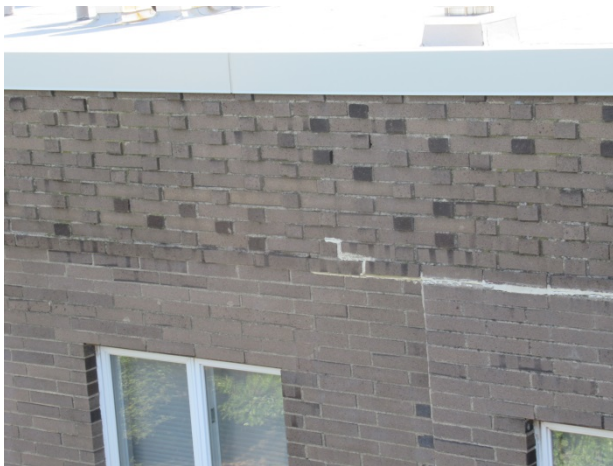
Previous repairs

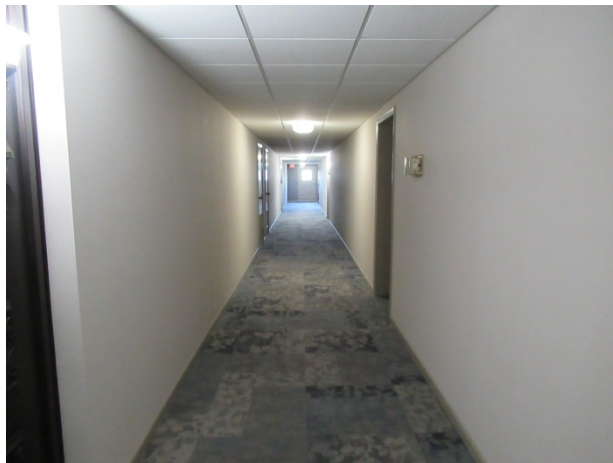
Condition: Good to fair with limited loose carpet squares and stains or discoloration evident

Hallway overview

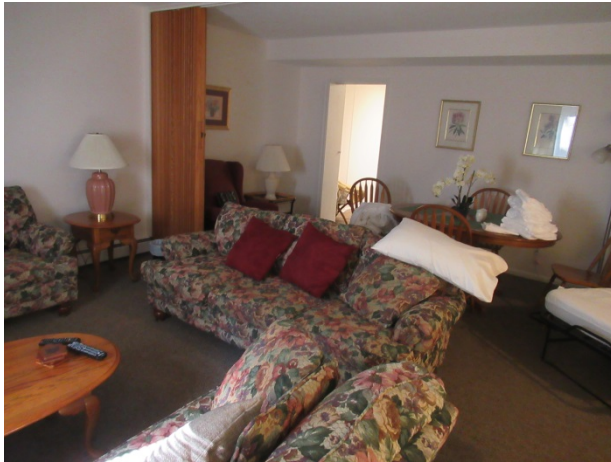
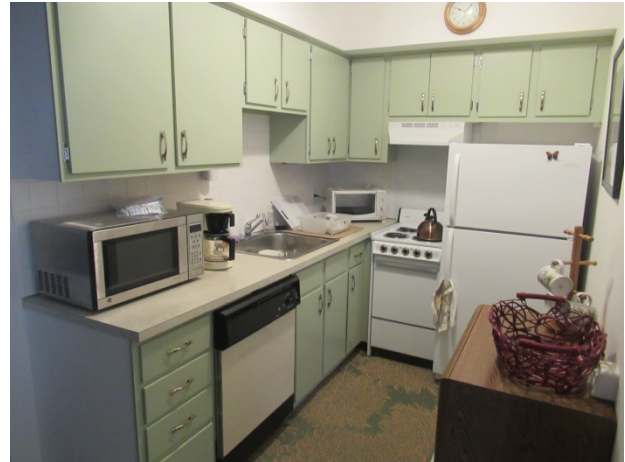
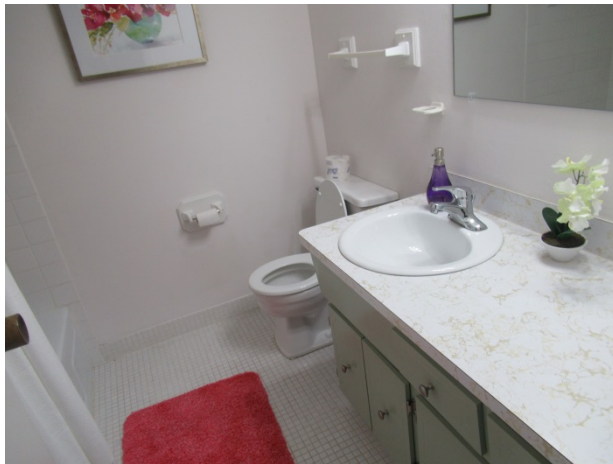
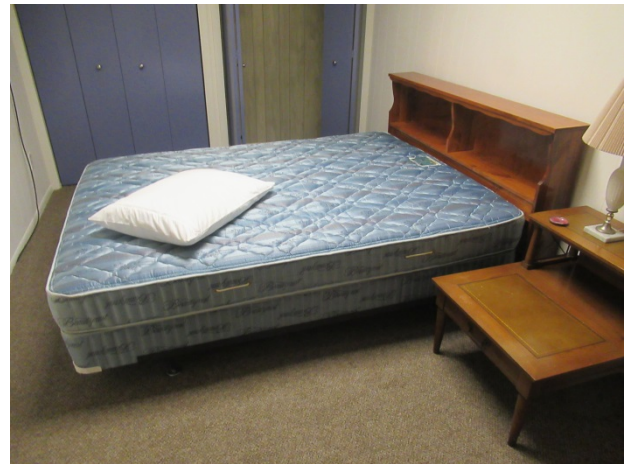
Condition: Good to fair, with a portion of the furnishings and fixtures appearing dated

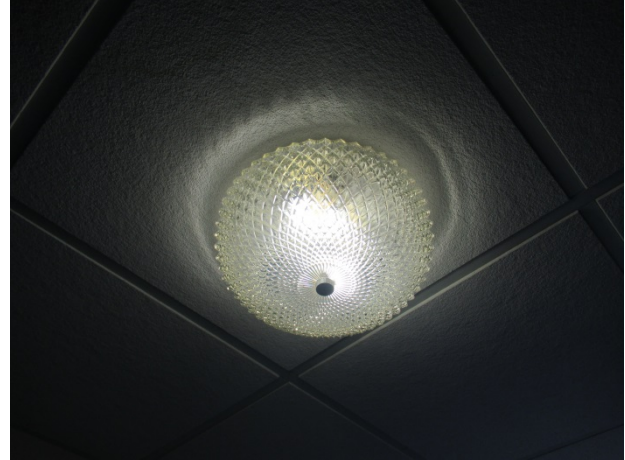
Ceiling light fixture

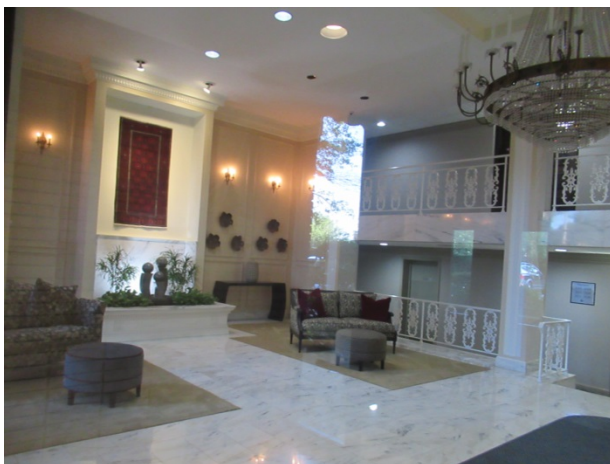
Lobby overview

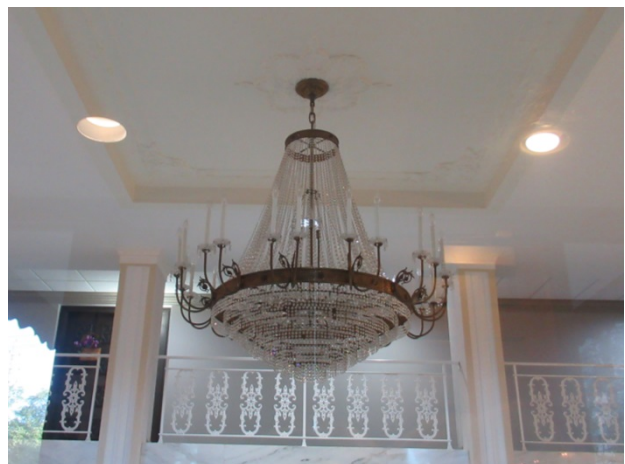
Chandelier

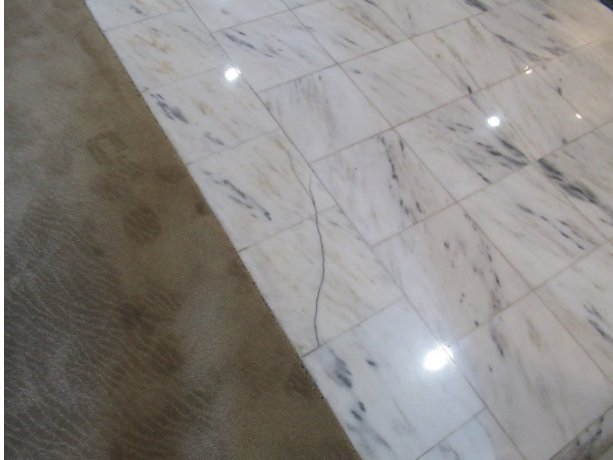
Tile crack

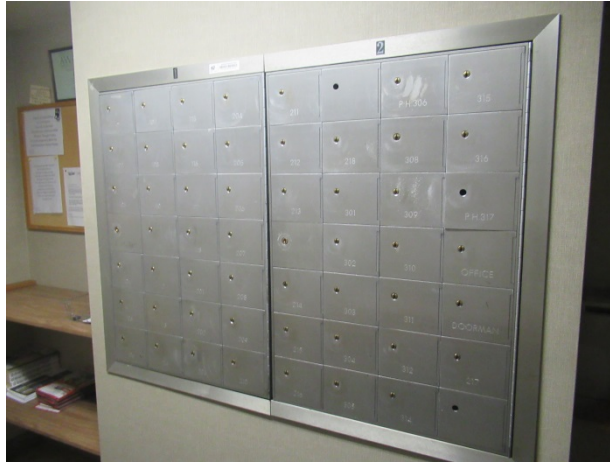
Condition: Reported satisfactory overall

Mailboxes

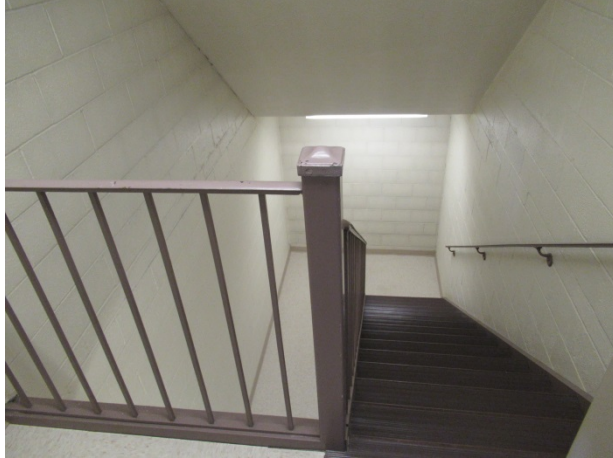
Conditions: Good to fair with isolated wall cracks and repairs evident

Stairwell finishes

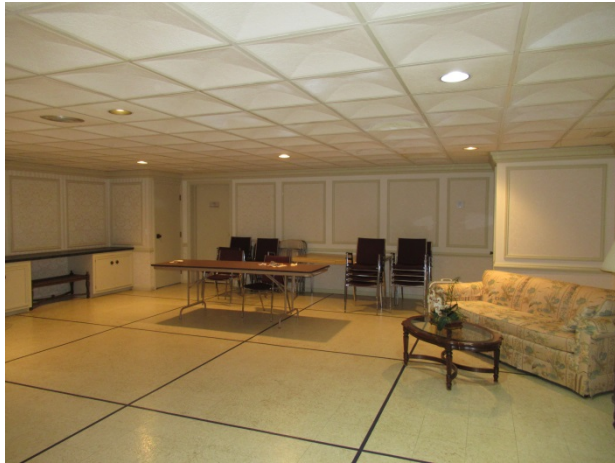
Condition: Fair to poor condition, with worn finishes and stained ceiling tiles. The kitchen fixtures appear dated.

Party room overview

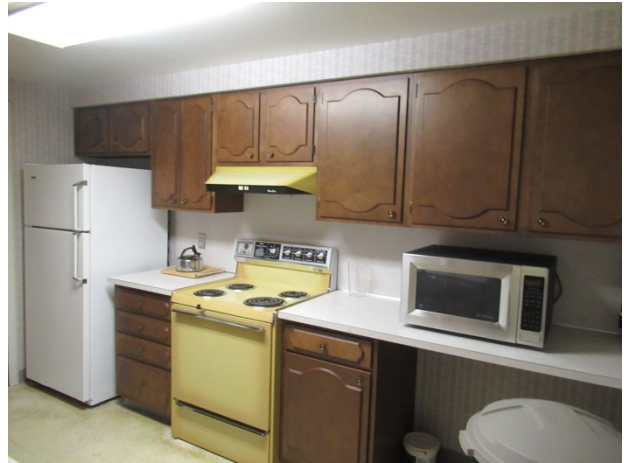
Party room kitchen

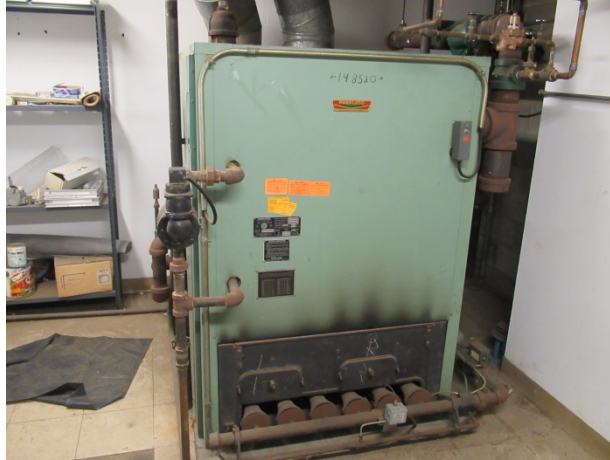
Condition: Reported satisfactory without operational deficiencies

Boiler

Expenditure Detail Notes: Expenditure timing and costs are depicted in the **Reserve Expenditures** table in Section 3. Our estimate of cost includes an allowance for replacement of the controls.

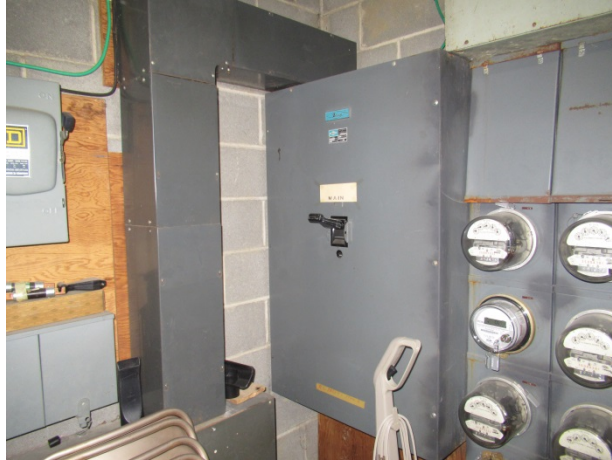
Condition: Reported satisfactory

Main disconnect

Expenditure Detail Notes: Expenditure timing and costs are depicted in the **Reserve Expenditures** table in Section 3. We recommend the Association budget to replace the main switchgear, distribution and circuit protection panels. Updates of this Reserve Study will consider possible changes in the scope and times of component replacements based on the conditions, including the need for replacement of the wires.

We recommend the Association conduct thermoscans of the distribution panels and circuit protection panels, and inspections of the transformers for any indications of arcing, burning or overheating on a regular basis, funded through the operating budget. Verification of the integrity of all connection points minimizes the potential for arcing and fires.

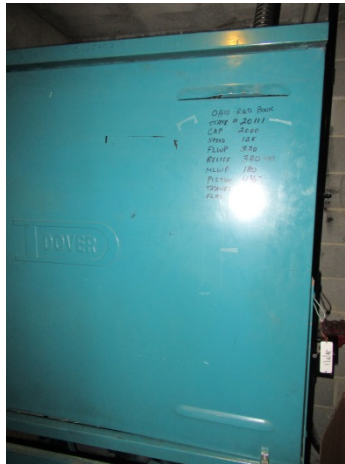
Condition: Reported satisfactory and service interruptions are reportedly infrequent. The pump is reported in satisfactory condition.

Pump housing

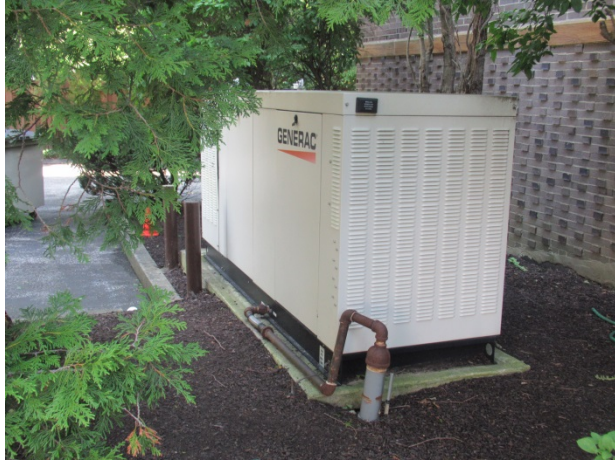
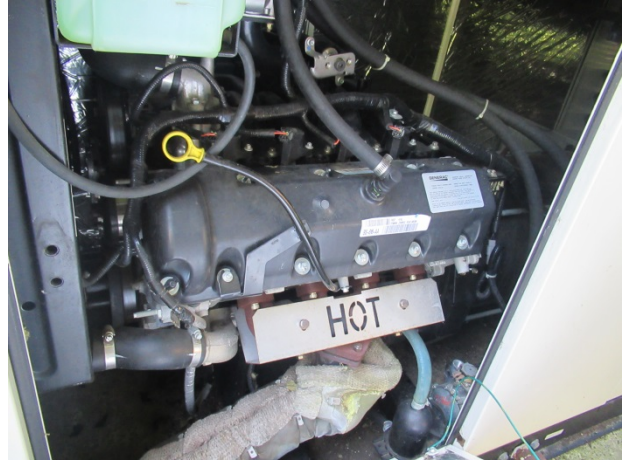
Condition: Reported satisfactory without operational deficiencies

Generator

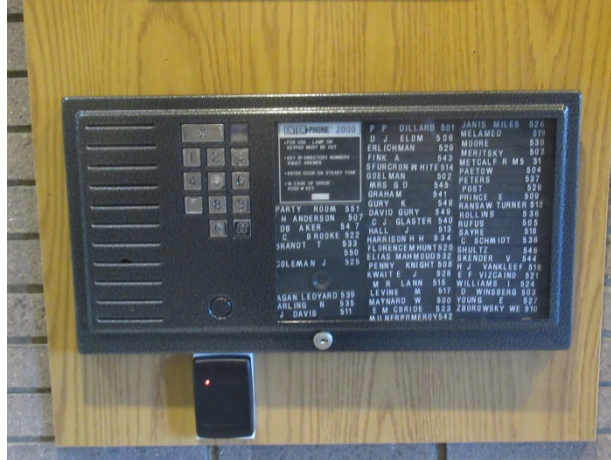
Condition: Reported unsatisfactory, the Association anticipates replacement in 2018

Intercom panel

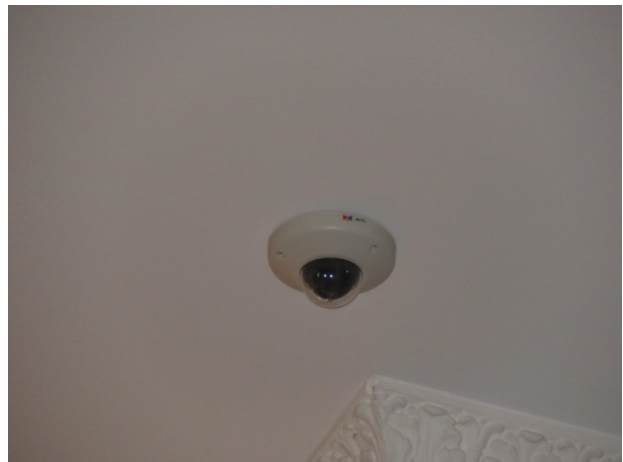
Condition: Reported satisfactory

Security camera

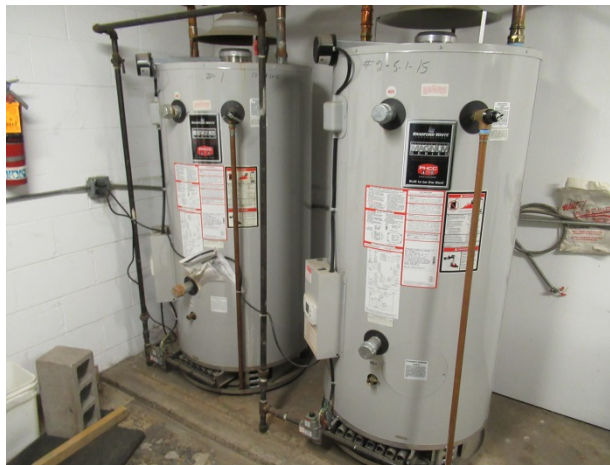
Condition: Reported satisfactory

Storage tanks

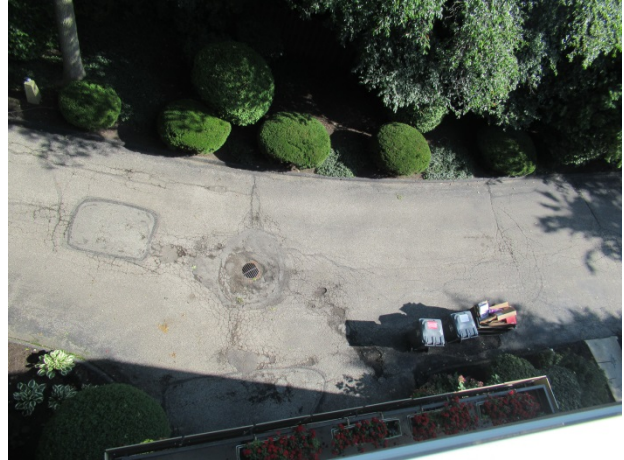
Condition: Fair to poor with cracks, pavement deterioration and potholes evident

Rear parking area pavement

History: Last repaved in 1992. The Association plans to mill and overlay the rear pavement in 2019, and crack fill and repair the front pavement.

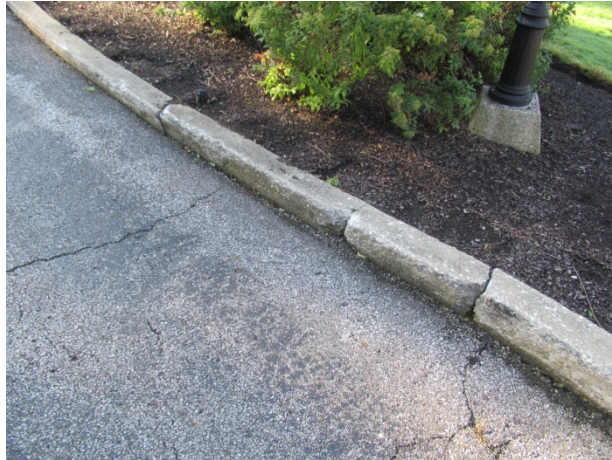
Condition: Fair with cracks evident

Curb cracks

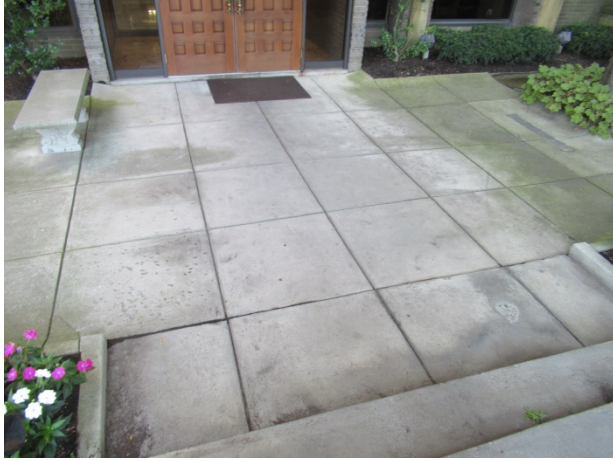
Condition: Good to fair, with spalls, cracks and areas of settlement present.

Entrance concrete

History: The Association plans to spend approximately \$6,500 in 2019 to replace the concrete flatwork at the garage threshold, the front driveway apron and partial replacements to the rear apron.

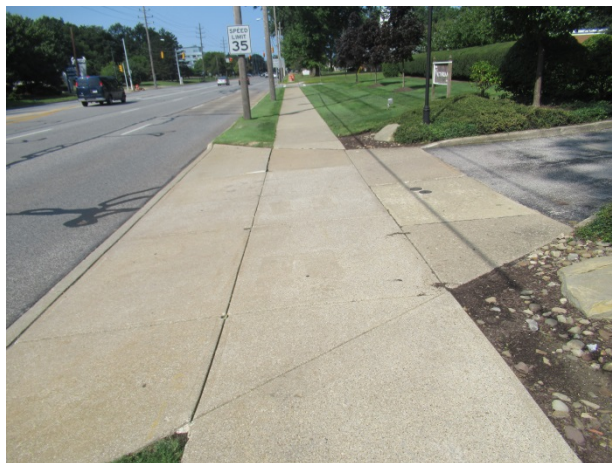
Front apron

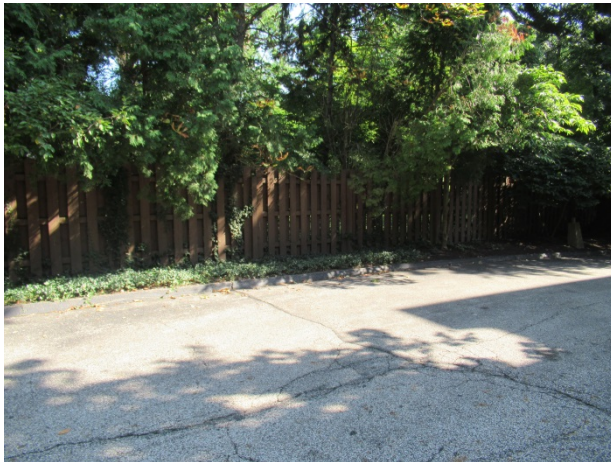
Condition: The wood fence is in good overall condition, we note leaning sections of the chain-link fence.

Wood fence

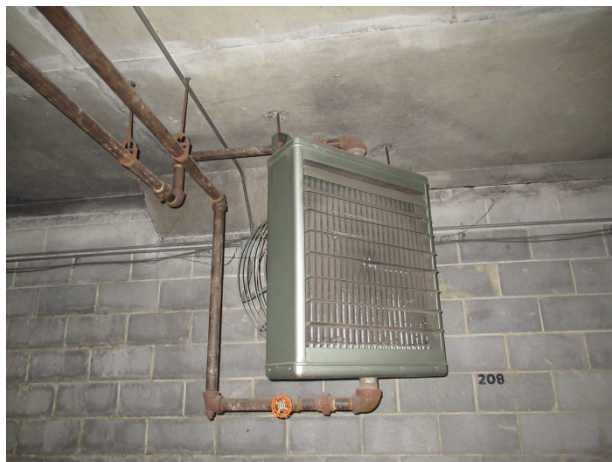
Condition: Reported satisfactory

Unit heater
