## RESERVE FUND STUDY REPORT

# ***SIERRAS ON THE LAKE CONDOMINIUM CORPORATION***

CONDOMINIUM PLAN No. 022 6881

MAY 2026  
FINAL

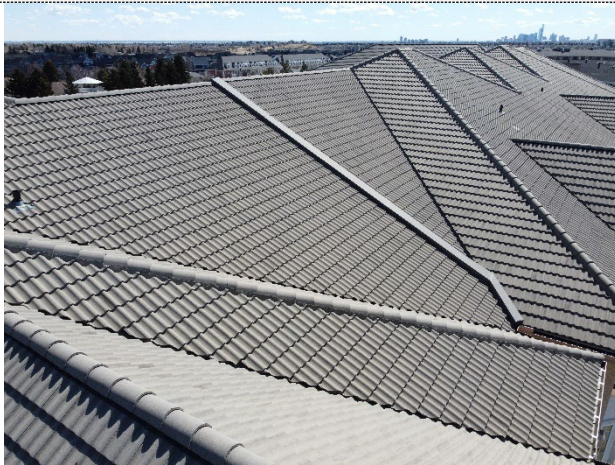
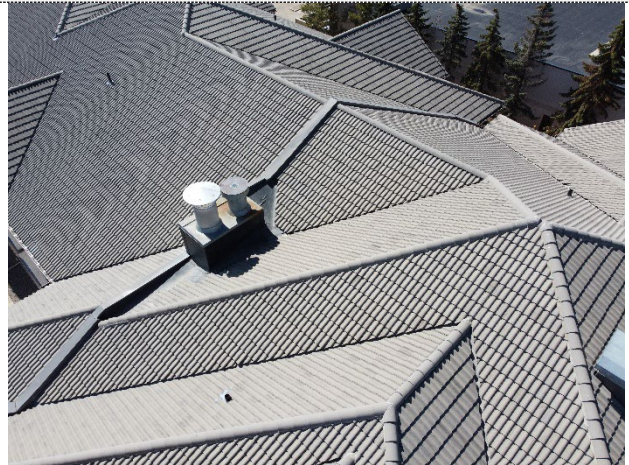
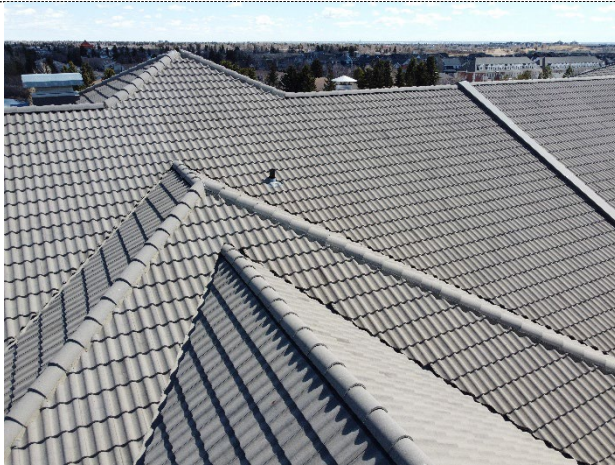
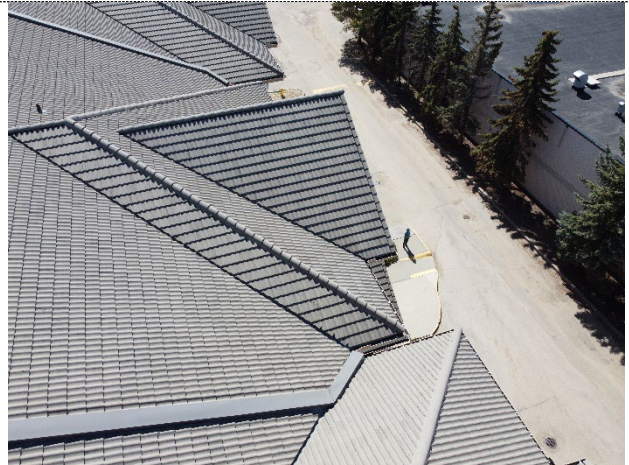
- The roof is constructed with concrete tiles installed over an underlying waterproof membrane. While concrete tiles are typically considered a lifetime material and can last indefinitely, the membrane beneath them could deteriorate over time due to weathering and wear. At the time of inspection, the roof system appears to be in good condition, with no deficiencies observed.
- A small section of flat roofing is located under the A/C unit. This area of roofing is covered with an SBS membrane.

Concrete roof tiles

| Component # | Recommendation | Page # in Report |
|---|---|---|
| 1.0 | Roofing consists of cement tiles, batten & membrane. Funds are allocated every 5 years to repair damaged/deteriorated areas of the roof. Ongoing repair will ensure that complete replacement may not be needed. | <u>14</u> |

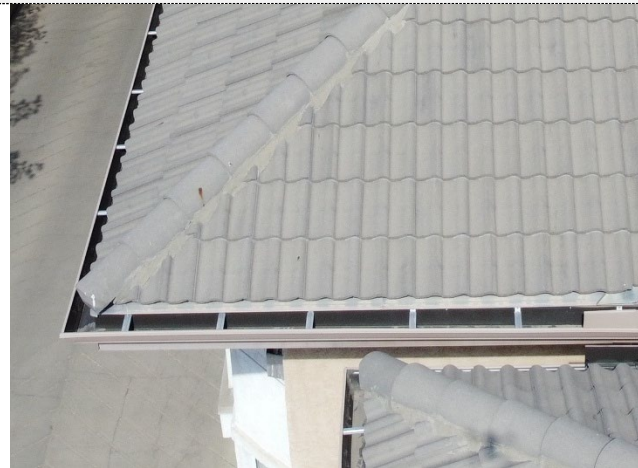
- Eavestroughs are securely fastened to fascia with hangers.
- Eavestroughs are free of debris.
- Downspouts terminate into eavestroughs, into drains and onto landscaping.
- Eavestroughs & downspouts were replaced this past year and are in good condition.
- Flashing has been added at inside corners of the eavestroughs.

Typical eavestroughs

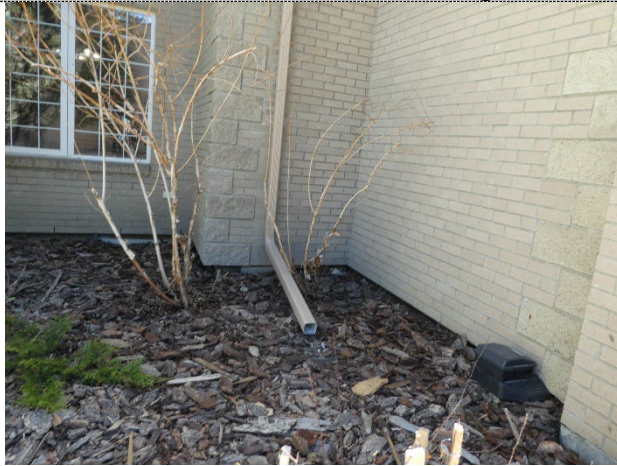
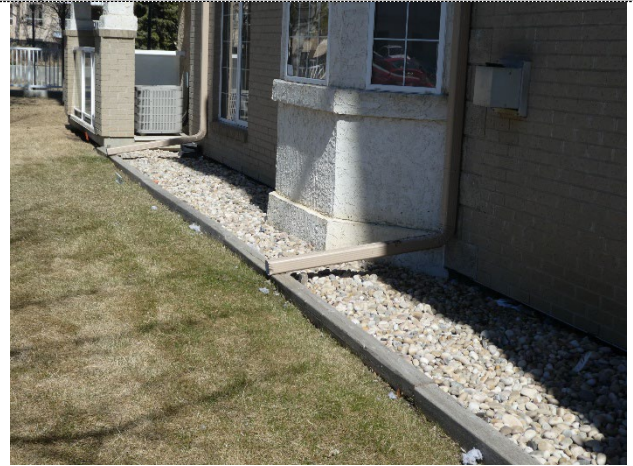
Downspouts terminating onto landscaping

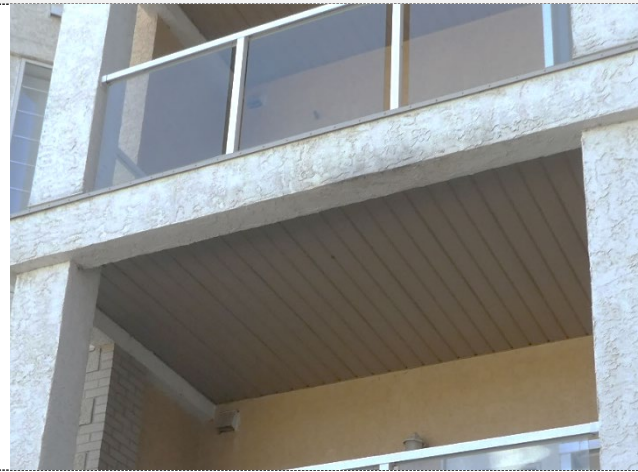
Balcony soffit

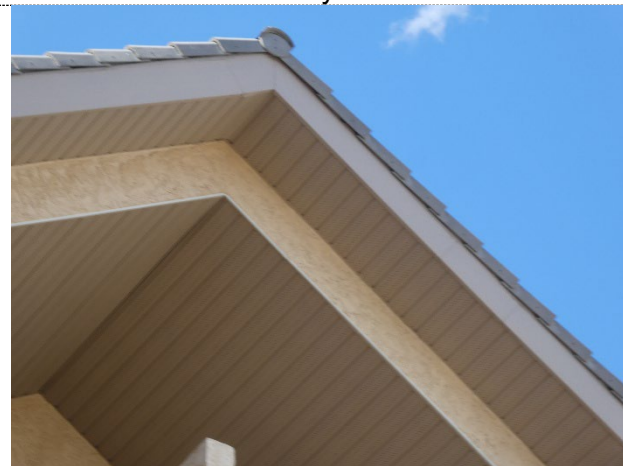
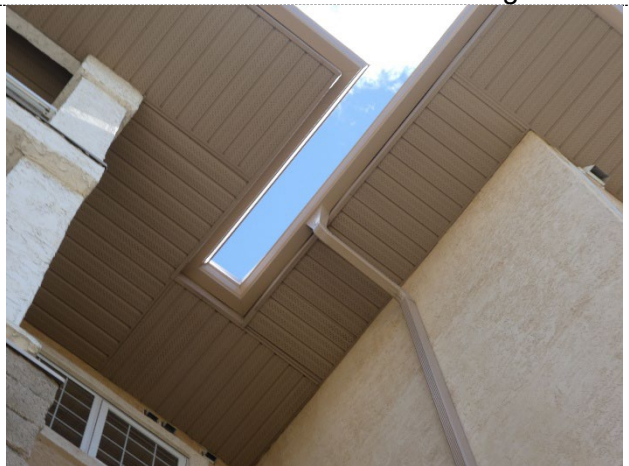
- Prefinished metal fascia is installed at all roof terminations.
- Soffit is vented painted metal and is installed at all roof overhangs and below balconies. Vented soffit allows for air into the attic spaces.
- Fascia was repaired this past year when eavestroughs were replaced.
- Fascia & soffit are original and in good condition.

Fascia & soffit

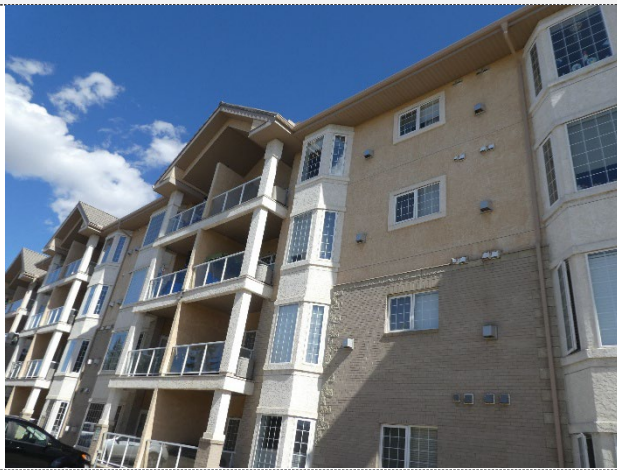
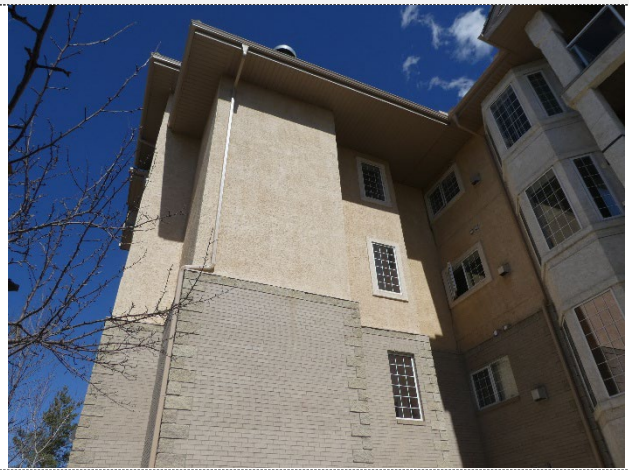
- The building is clad with stucco and brick veneer.
- Brick & stucco should not require complete replacement if regular maintenance & repair as completed.
- Brick is in good condition.
- Stucco is evidencing discoloration & cracking in some locations.
- Stucco deterioration is noted on architectural reveals.
- Parging is installed below the stucco to grade at some areas.

Brick & stucco finish

| Component # | Recommendation | Page # in Report |
|---|---|---|
| 4.0 | Building is clad with stucco & brick veneer. Stucco is evidencing some deterioration. Funds are allocated within the next 2 years and every 4 years to repair exterior finishes of the building. Ongoing repair is necessary to eliminate complete replacement of stucco & brick veneer. | <u>20</u> |

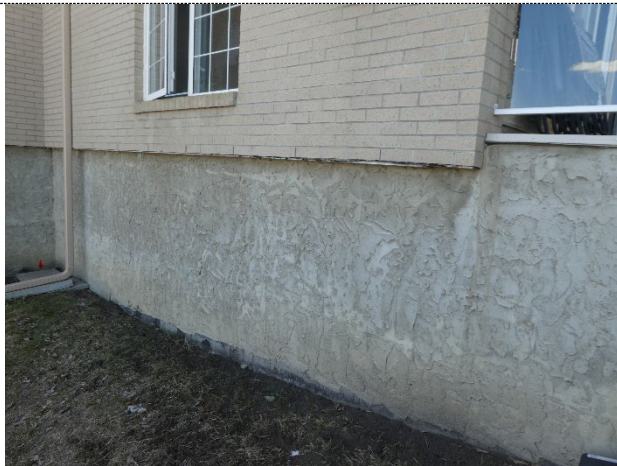
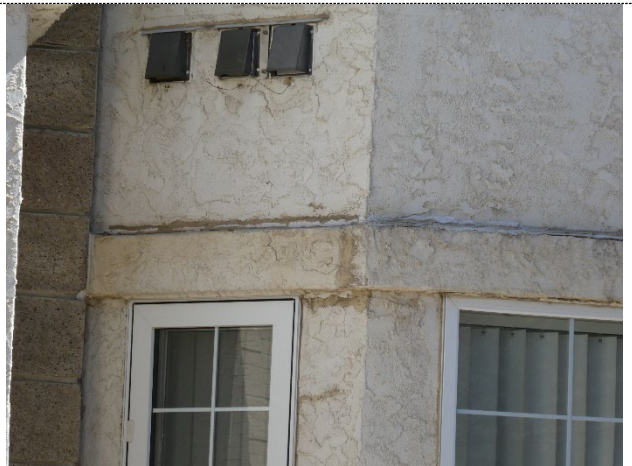
Parging

Damaged stucco

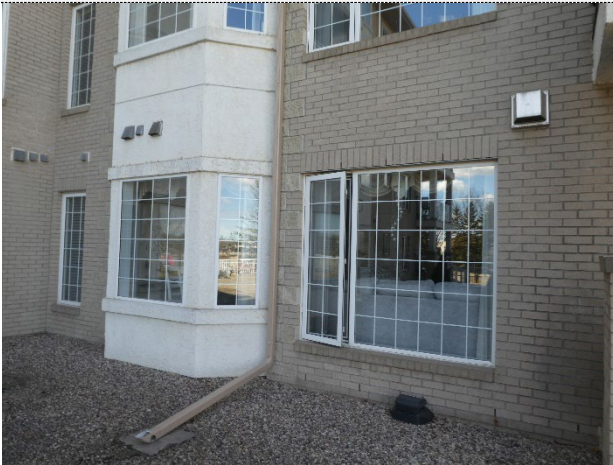
- All windows are original and in fair condition.

Unit windows

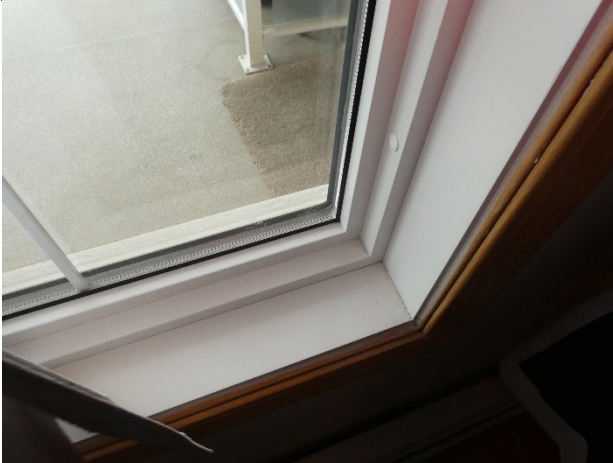
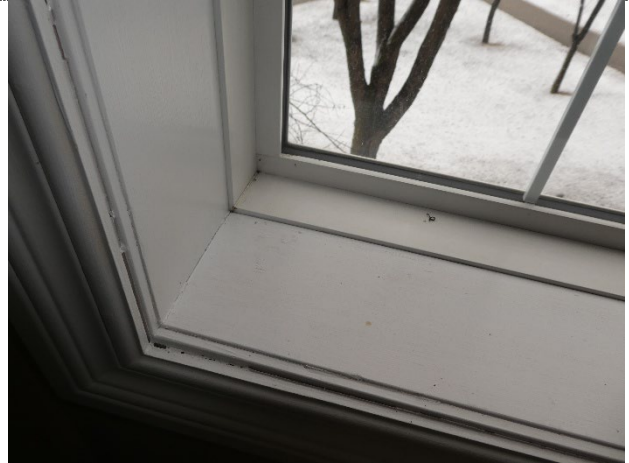
Interior view of windows

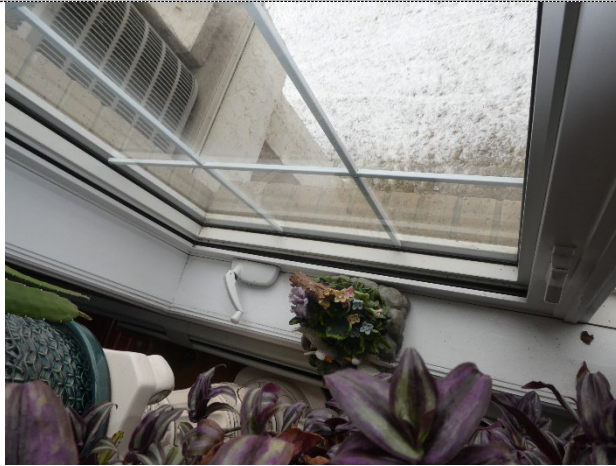
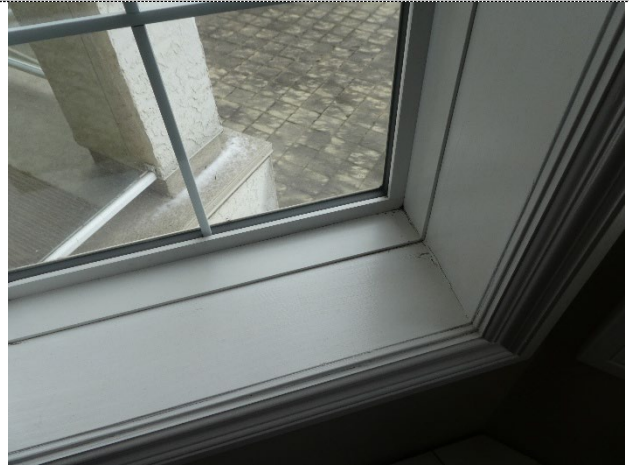
Interior view of windows

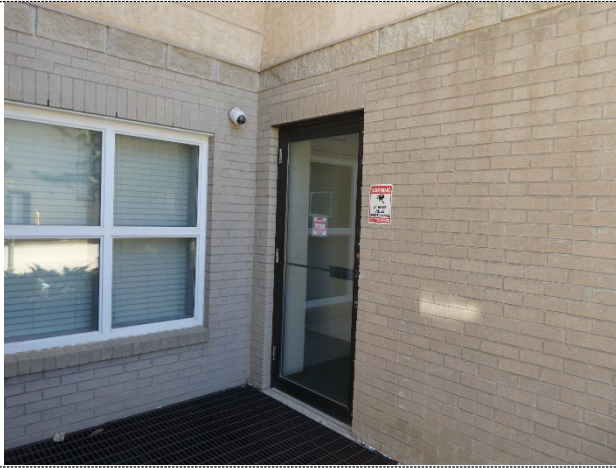
Stairwell entrance

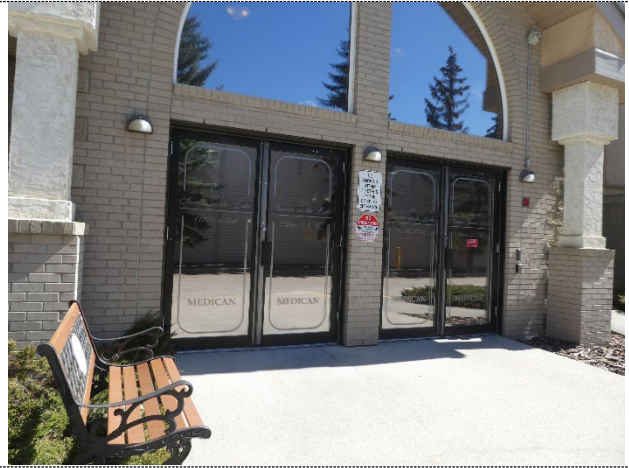
Front entrance

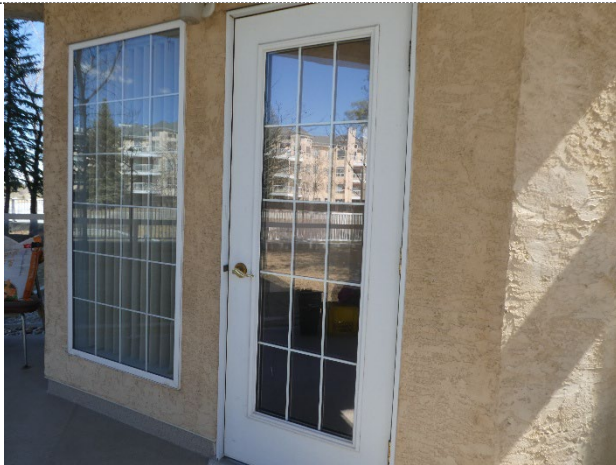
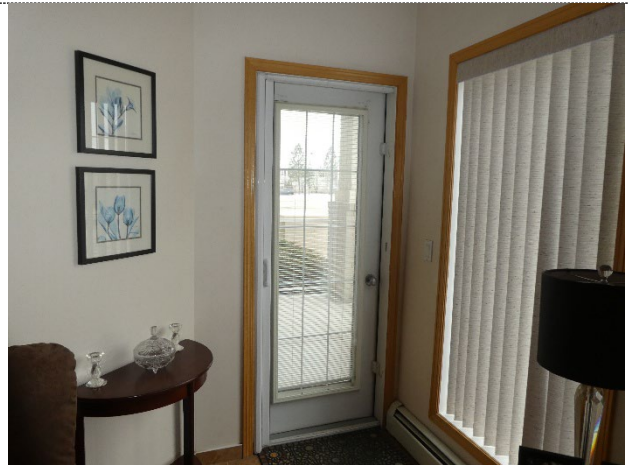
Balcony doors

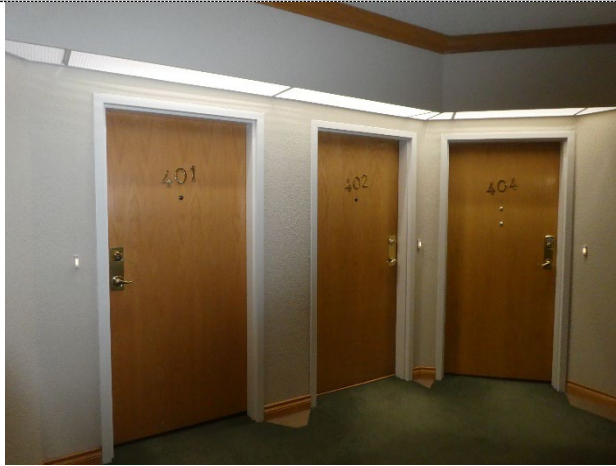
Interior unit doors

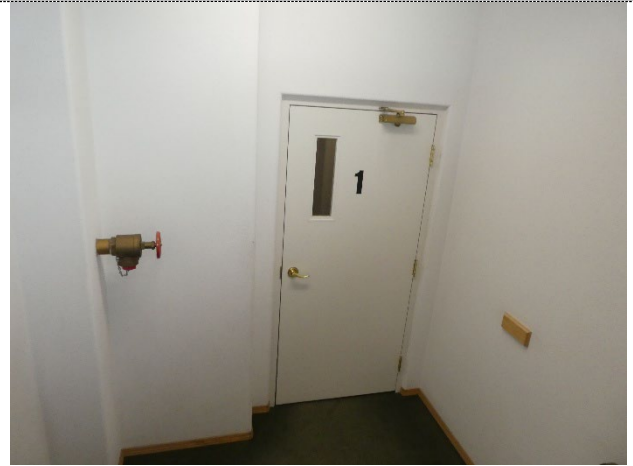
Stairwell door

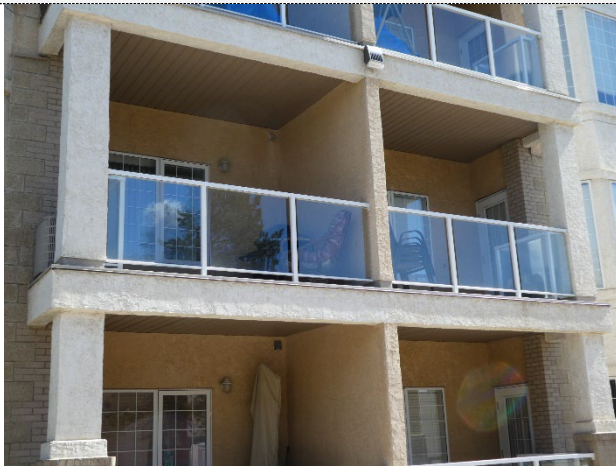
- Balconies consist of a wood structure, plywood decking, PVC membrane, stucco clad fascia & columns and metal and glass railings.
- Balconies were repaired in 2021. This included adding a clamping bar to curling membranes & patching damaged membranes.
- Balcony membranes are nearing the end of their effective life.
- Railings are in good condition.
- Balcony fascia and column cladding is evidencing deterioration.

Typical balconies

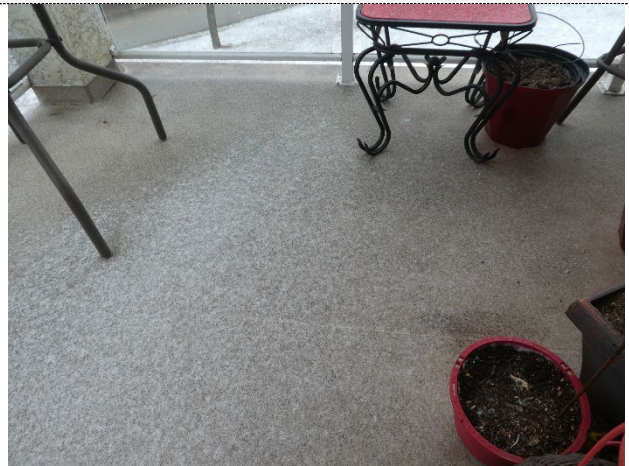
Balcony membrane

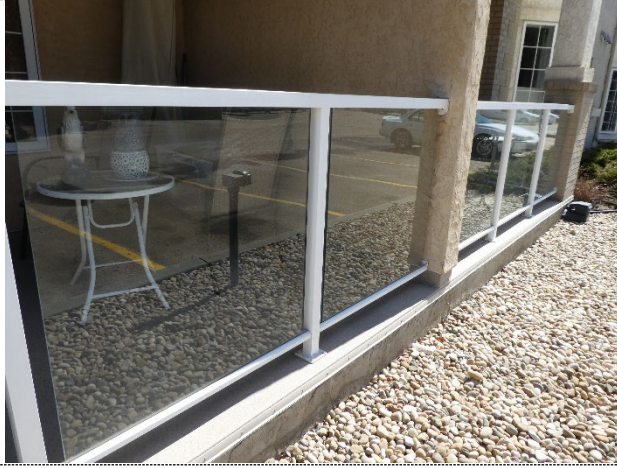
Balcony railings

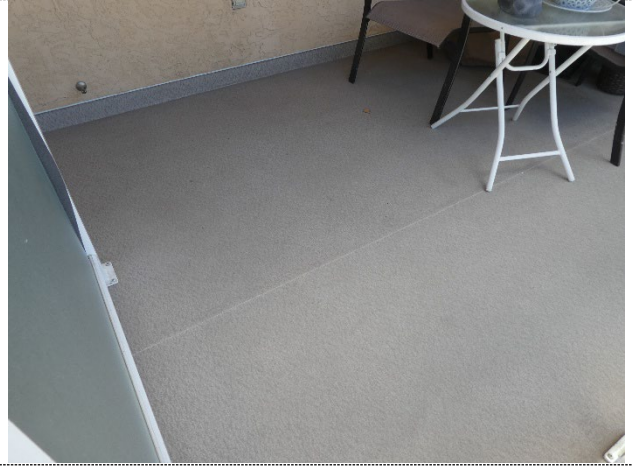
Balcony membrane

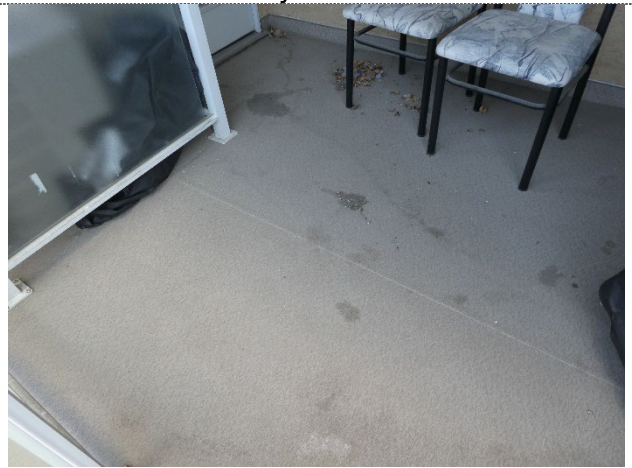
Balcony membrane

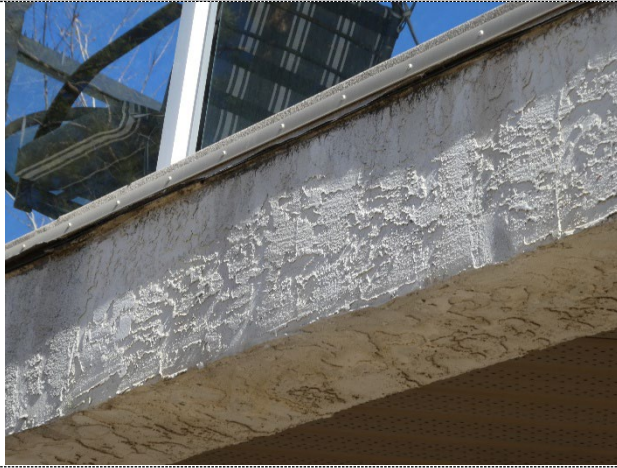
Balcony fascia & clamping bar

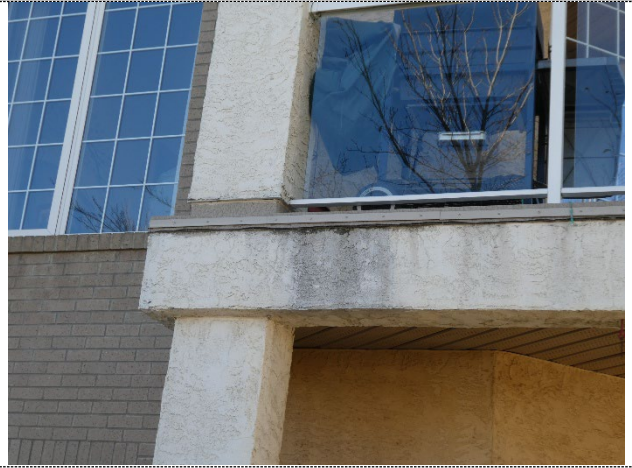
Discolored fascia

- Balcony membranes will require replacement within the next 7 – 8 years.
- Stucco covered balcony posts & fascia should be replaced with vinyl/metal within the next 7 – 8 years in conjunction with membrane replacement.

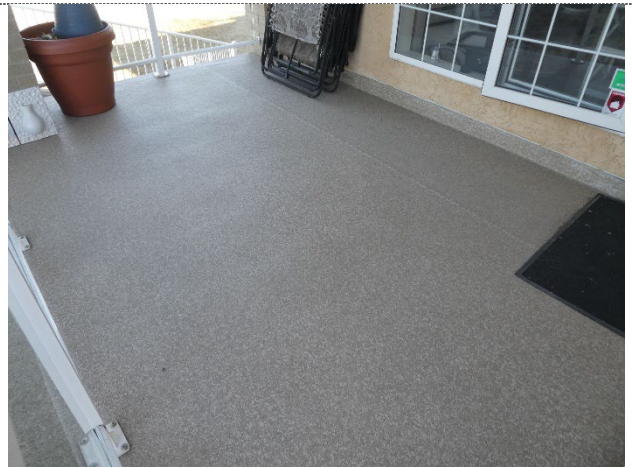
Balcony membrane

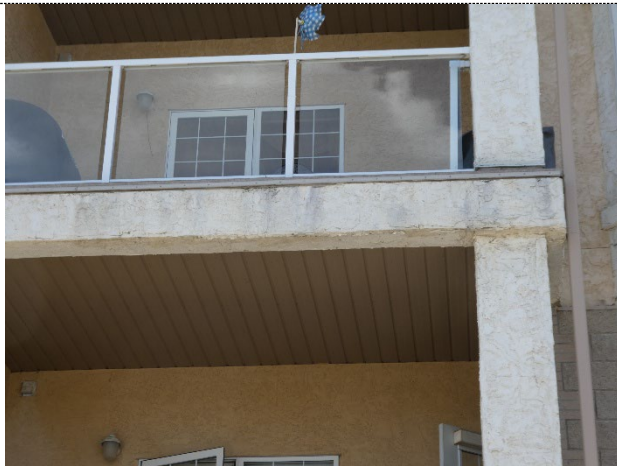
Discolored fascia

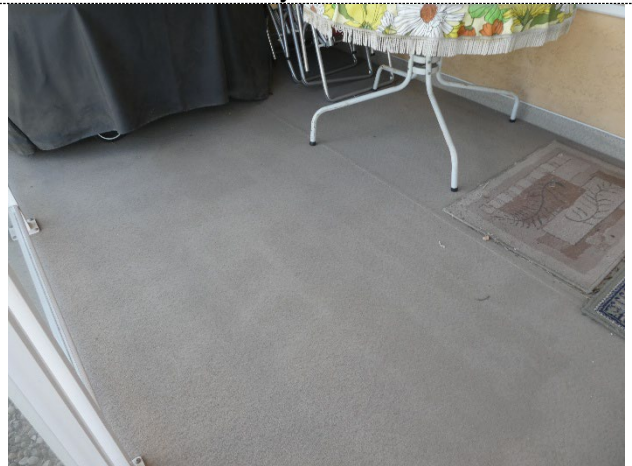
Balcony membrane

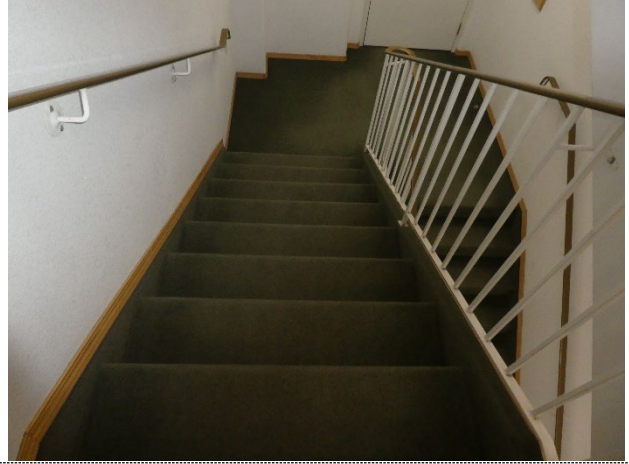
- Carpet is installed in the hallways, lobby, stairwells & amenities/social rooms.
- Carpet is original and is at the end of its effective life.
- Tile is installed in the front lobby & pool area. Tile is all original. Some damage was noted in the pool area.
- Linoleum (vinyl flooring) is installed in the washrooms, kitchen, garbage rooms & stairwell exits. Linoleum is in fair condition.
- Laminate is installed in the social room & guest rooms and is in good condition.
- The pool membrane/paint finish was recently replaced and is in good condition.

Carpet in stairwell

| <b>Interior Flooring Finishes – continued</b> | | |
|---|---|---|
| <ul style="list-style-type: none"> <li>– Follow manufacturer’s recommendations for care and cleaning of all flooring finishes.</li> <li>– Replace carpet in all common rooms this year.</li> <li>– Replace hallway &amp; stairwell carpet within the next year.</li> <li>– Funds are allocated next year and every 5 years to repair damage tile flooring in the pool area.</li> </ul> | | |

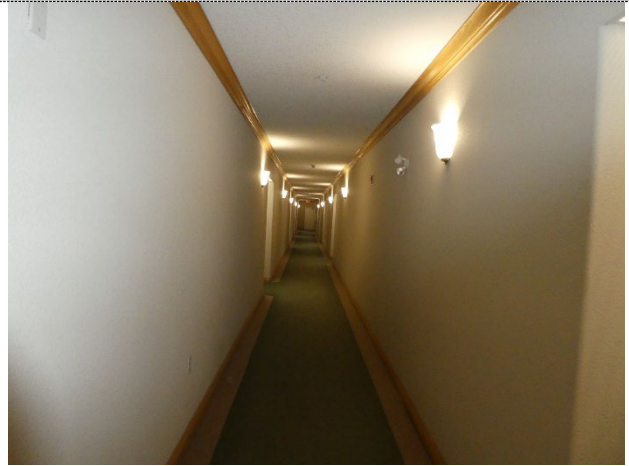
- All interior paint finishes are original and in fair condition.
- Some settlement cracking was noted in a few locations.

Hallway paint finishes

- Main floor & 2<sup>nd</sup> floor common areas should be painted this year.
- Hallways & stairwells should be painted next year.
- Painting should be completed after carpet installation. It is more effective to cover flooring properly than repair damages to freshly painted walls due to carpet removal & installation.

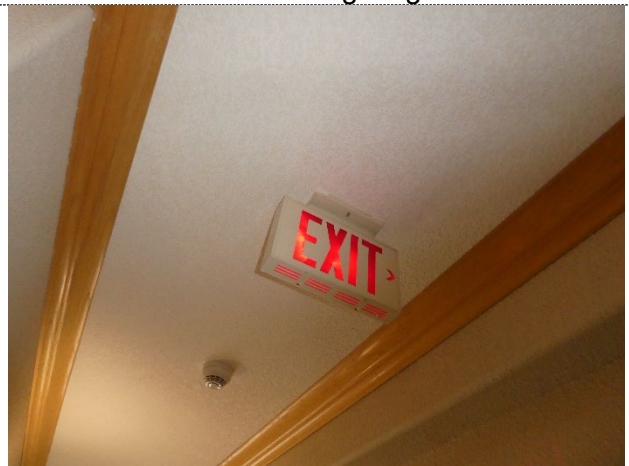
- Specialty lighting includes pool table lights and any chandeliers. These light fixtures are original and in fair condition.
- Emergency & exit lighting is original and nearing the end of its effective life.

Exit signage/lighting

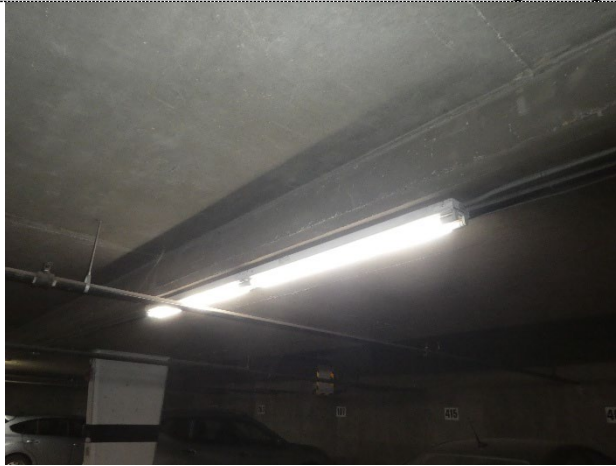
- Parkade lighting was replaced approximately 9 years ago and is in good condition.
- Exterior unit light fixtures are original. LED retrofits may have been completed in 2016, however the fixture is original.

Parkade lighting

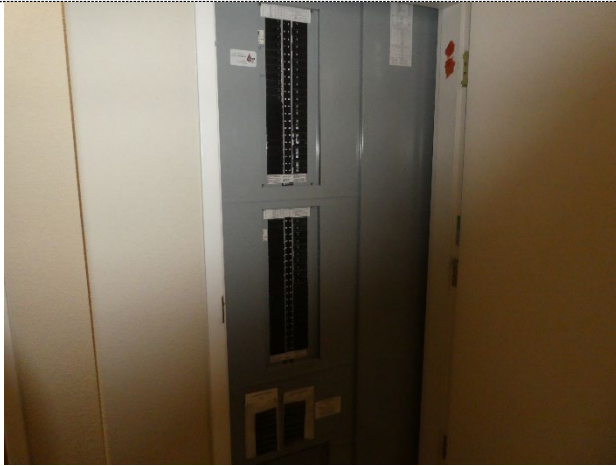
- Electrical distribution for the building is in good condition.

Breaker panel

- Electrical components should be included in a regular maintenance schedule.
- Funds are allocated every 10 years to complete major repairs to electrical distribution. Repair as needed.

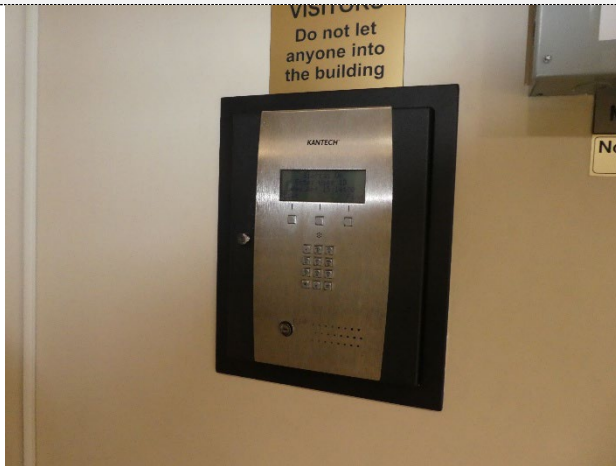
- A Kanteck intercom panel is located at the front entrance between the security doors. Intercom panel/system was replaced approximately 5 years ago and is in good condition.
- A fob proximity reader system is installed at all exterior building doors for security. System is in fair condition.
- The security camera system consists of a recording devise in the office and multiple cameras throughout the interior & exterior of the building.
- A handicap access system has been installed at the front entrance within the last year. This system opens the front entrance door remotely for handicap access.

Intercom panel

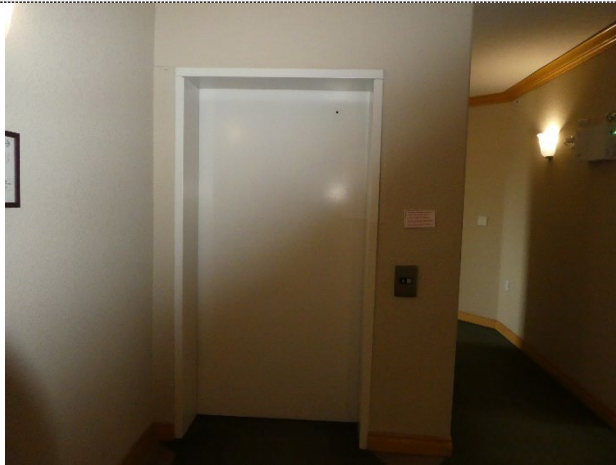
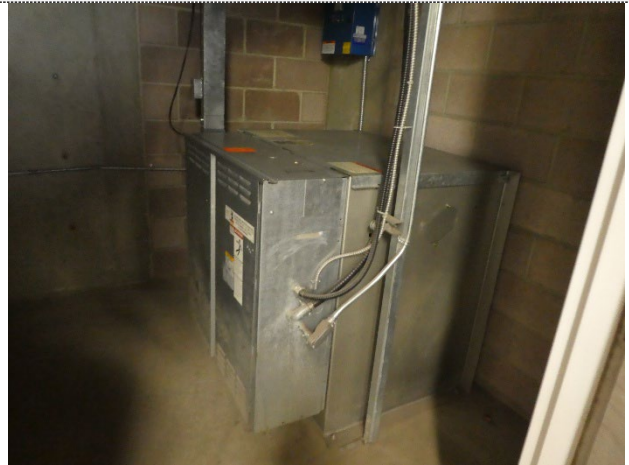
- The building is serviced by 3 Otis hydraulic elevators.
- Elevators are located: south end, north end & middle.
- Elevators are original and in fair condition.

Typical elevator door & hydraulics

- Funds are allocated within the next 5 years to complete major repairs to all 3 elevators.

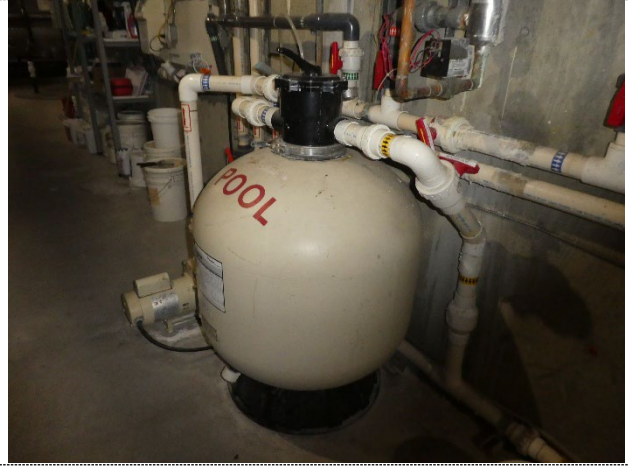
- Pool mechanical consists of filters, pumps, water chemistry controller & chlorine generator.
- There are 2 Tagelus filters. Filters are original.
- There are 2 water pumps. These pumps were replaced approximately 4 years ago.
- There are 2 peristaltic pumps that were also replaced approximately 4 years ago.
- Chlorine generator is original.
- The water chemistry controller was also replaced approximately 4 years ago.
- The majority of the pool mechanical components have been recently replaced and are in good condition.
- Filters & chlorine generator are in fair condition.

Filter

- Continue with ongoing maintenance & repair.

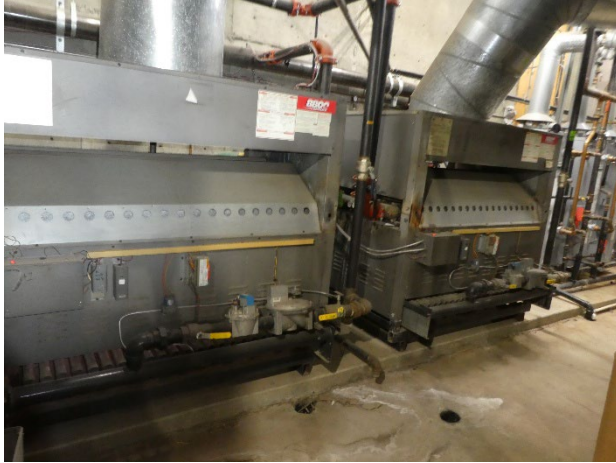
- The building is serviced by 2 RBI boilers.
- Boilers are original and in fair condition.

RBI heating boilers  
M: 33HB24002EOSSSS  
S: 080228996 & 080228995

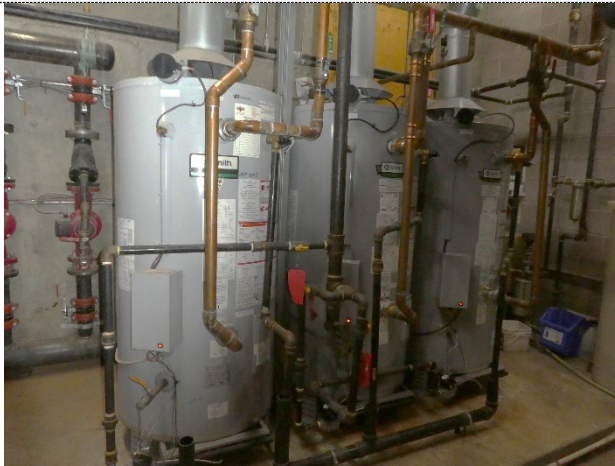
- The building is serviced by 3 A.O.Smith 100 gal hot water heaters. 2 heaters were replaced in the 2025 fiscal year (Jan 2026 & Mar 2026). 1 heater is nearing the end of its effective life.
- The water softener system was installed recently and appears to be in good condition.
- Miscellaneous mechanical components include: pumps (water & sump), controllers, exhaust fans, expansion tanks, etc. All of these components vary in age and condition.
- Domestic water & heat loop piping runs through the building. Piping is original.
- Thermostats & zone valves are original.

A.O.Smith hot water heaters – 100 Gal  
M: BTRC400A 118 S: 9281001006 &  
2547146128596 & 2609147289744

- Replace one hot water heater (Oct 2015) within the next 3 years.
- Funds are allocated every 5 years to repair/replace damaged domestic water & heat loop piping. Repair/replace as needed.
- Funds are allocated every 3 years to replace miscellaneous mechanical components listed above. Replace as needed.

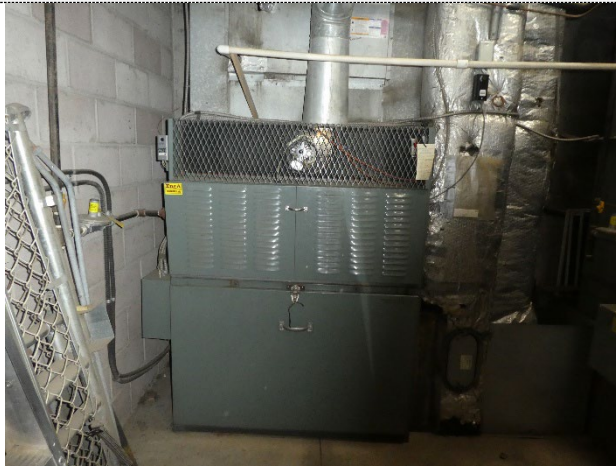
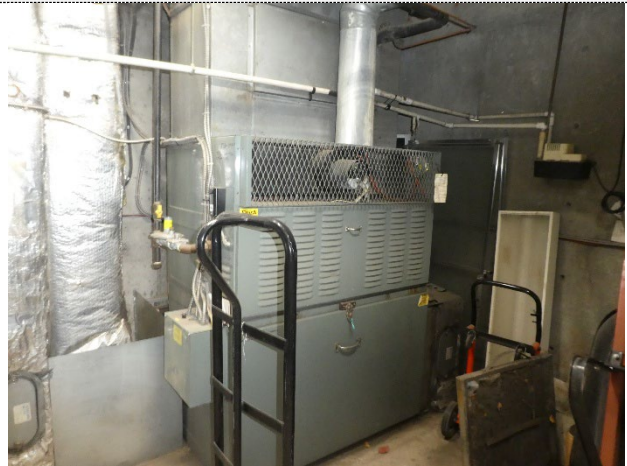
- The building is serviced by 2 Eng A furnaces located in the parkade & one hallway makeup air unit located in the attic space. The furnaces & the makeup air unit service the hallways.
- The parkade makeup air unit is located in the boiler room.
- There is one large carrier A/C unit installed on the roof and several small units located on the east & south side of the building.
- All furnaces, makeup air units are original.
- Small A/C units vary in age, size & manufacturer.

Eng A furnaces – M: XE320HB

- Continue with regular maintenance and inspection.
- Funds are allocated to replace 3 small A/C units every 5 years. Replace as needed.

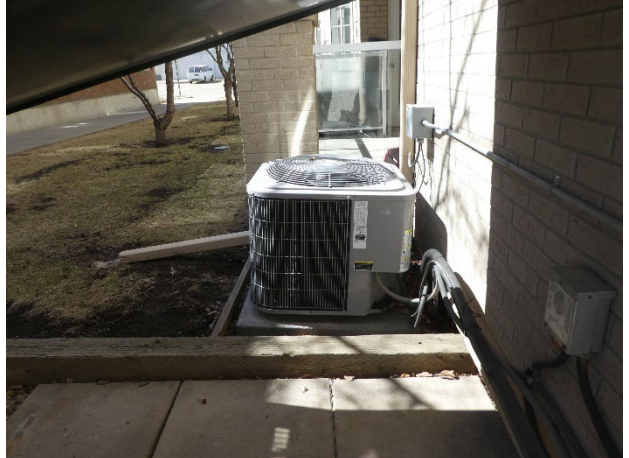
Smaller A/C units

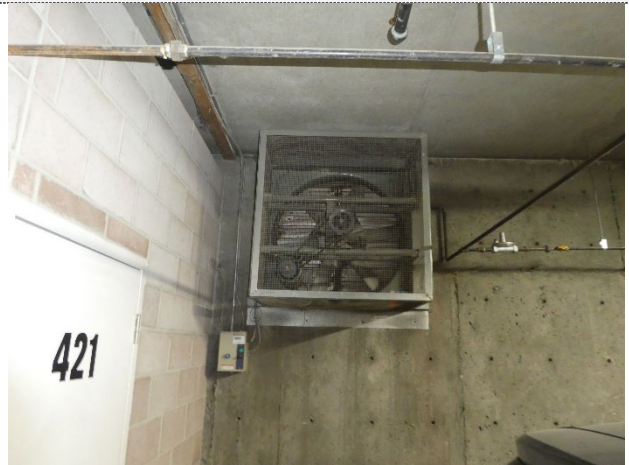
- Air is circulated in the parkade by an ICE makeup air unit, exhaust fans & heaters.
- Makeup air unit, exhaust fans & heaters are original and in fair condition.
- A QEL gas monitoring system is installed in the parkade. This system was replaced approximately 9 years ago and is in fair condition.

Exhaust fan

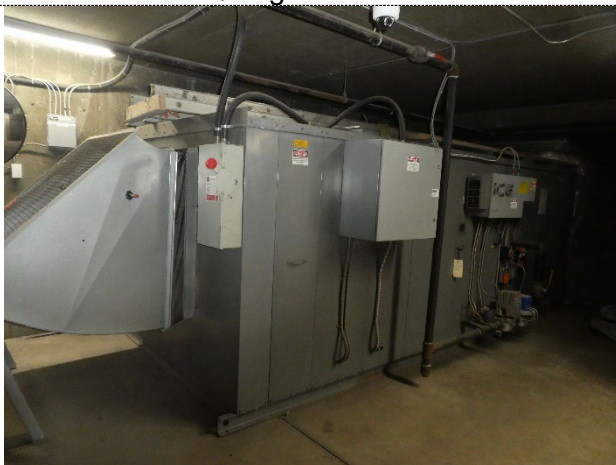
ICE makeup air unit  
M: BMA136XDA  
S: 27945B0209

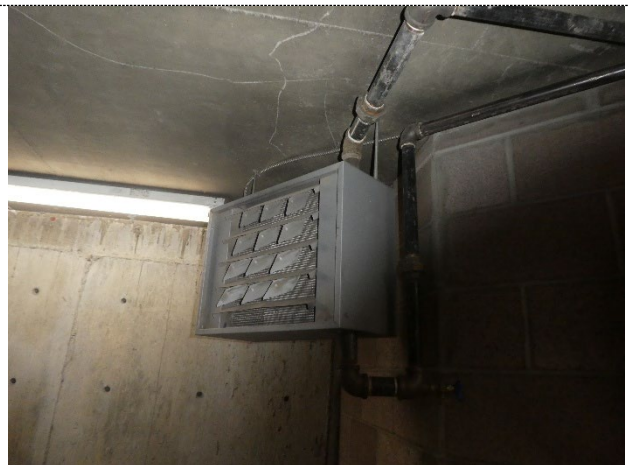
Fan coil heater

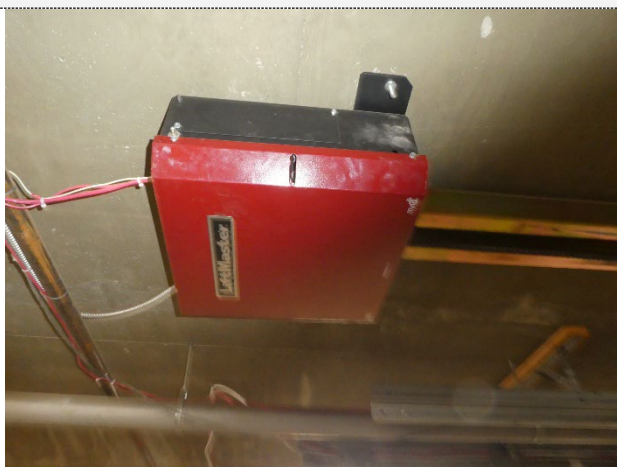
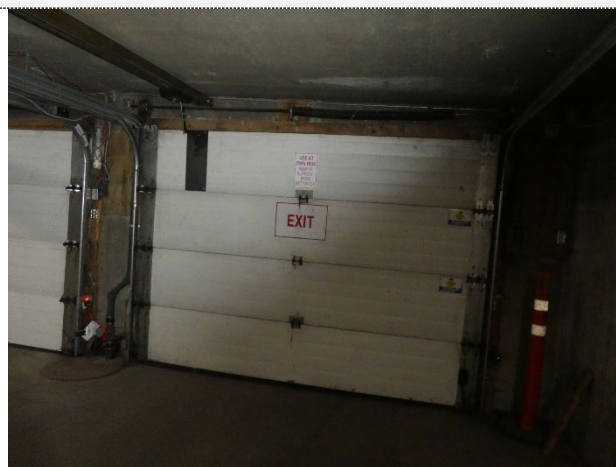
- There are 2 overhead parkade doors for vehicle access/exit.
- Doors & motors are not original and appear to be in good condition.
- The reader/controller was recently replaced and is in good condition.

Exit parkade door & motor

| <b>Overhead Parkade Doors – continued</b> | | |
|---|---|---|
| – Doors can generally last indefinitely and are usually replaced due to impact. | | |

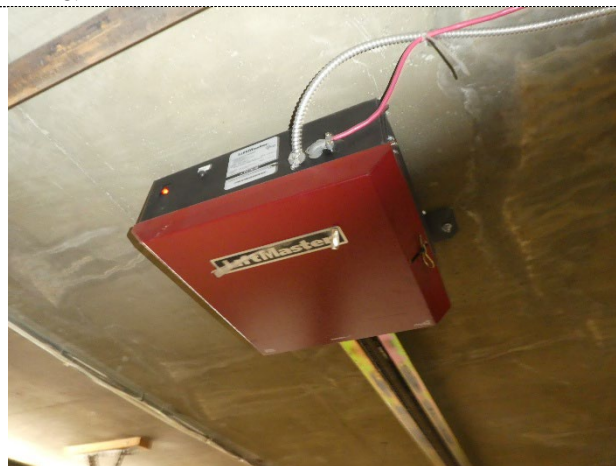
Entrance parkade door & motor

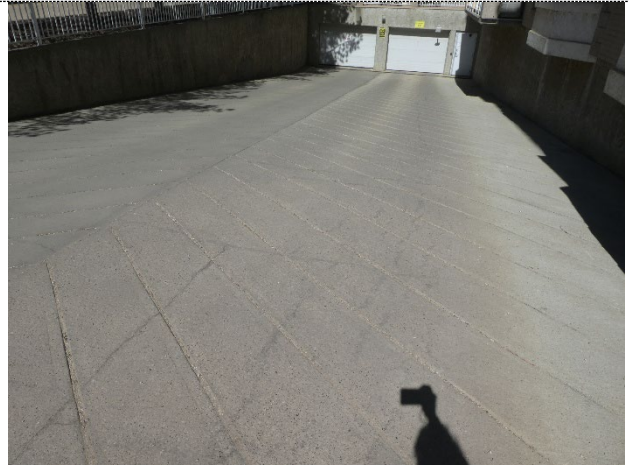
- A glycol heat loop system is installed in the concrete to ensure that the concrete does not ice up in the winter months. Inspection of the piping is not possible for this report. When failure occurs, the ramp will start to freeze in areas. Generally, these systems last about 35 years.
- The concrete ramp is original and in fair condition.

Parkade ramp

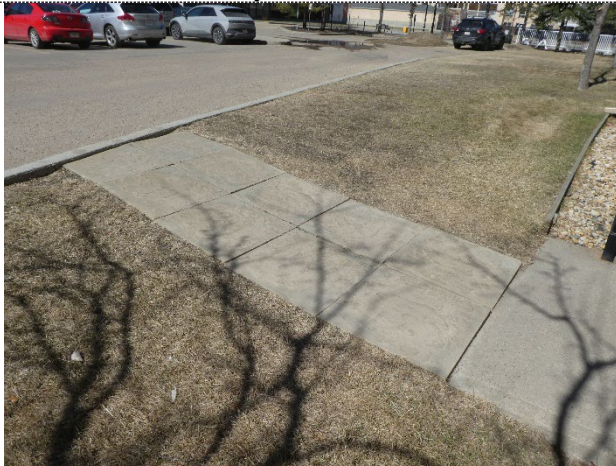
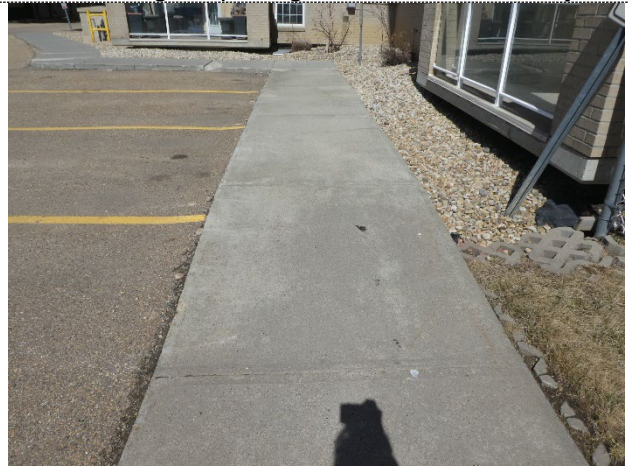
- Poured concrete walkways are installed at the west & south sides of the building.
- Concrete walkways are original and evidencing deterioration.

Walkways along west of building

- Walkways should be replaced in a phased program. Funds are allocated to replace 1/3 of the concrete walkways every 5 years.
- It is recommended that salt based ice melt products not be used.

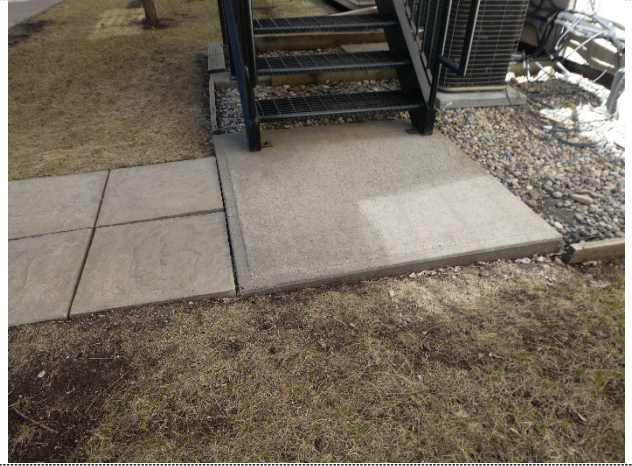
Concrete - south

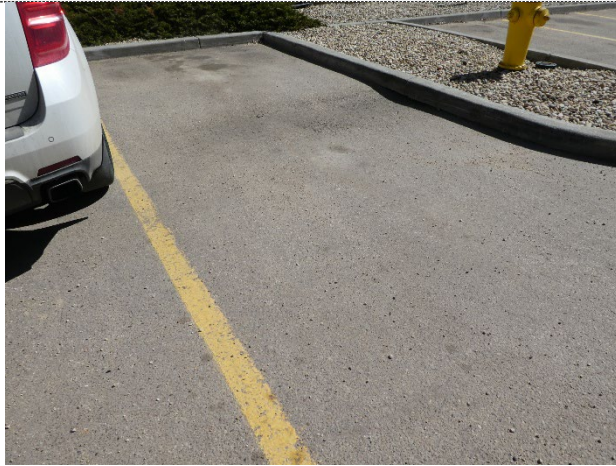
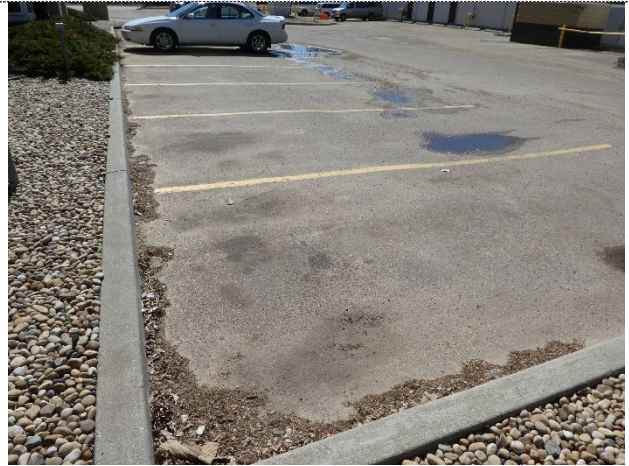
- Poured concrete curbing is installed around the perimeter of the asphalt. Curbing is original and in good condition.
- Asphalt parking & roadways are also original and evidencing wear.

Asphalt parking

- Parking & roadways should be completely resurfaced within the next 4 years. If resurfacing is postponed, a complete replacement at double the cost may be necessary.
- Funds are allocated to patch and repair asphalt every 5 years thereafter.
- It is recommended that salt based ice melt products not be used.

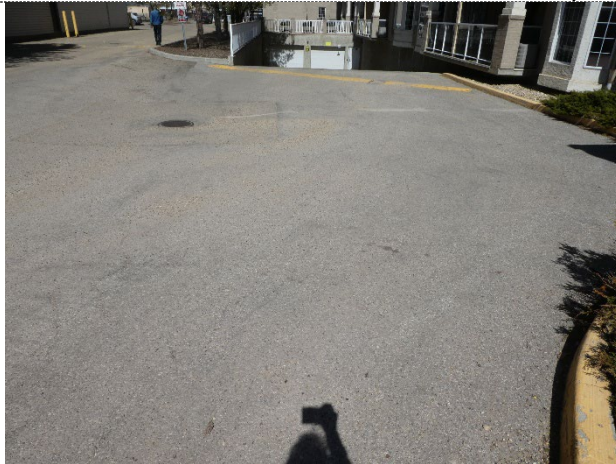
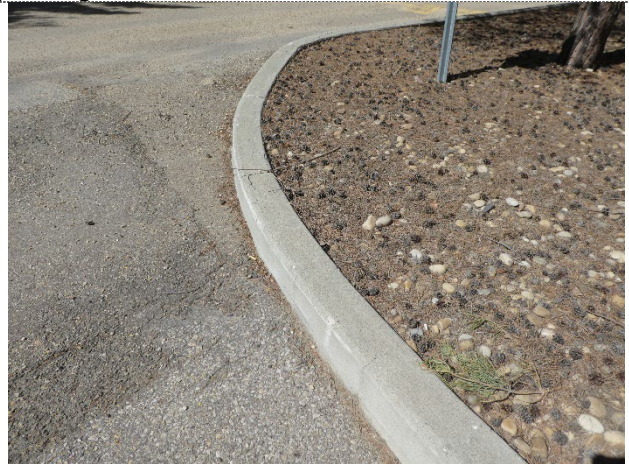
Asphalt roadway

Poured curbing

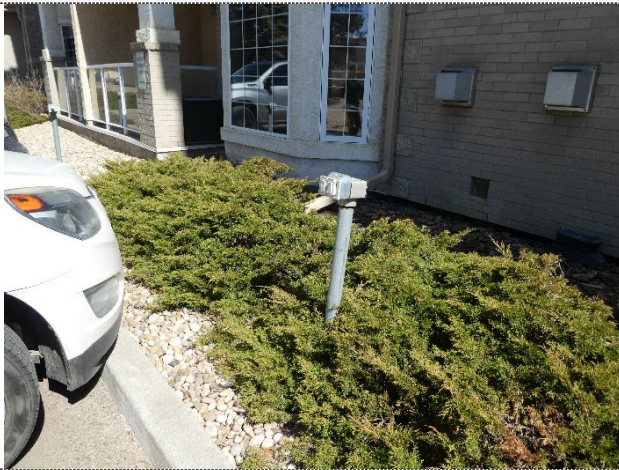
- Vehicle outlets are installed in the landscaping along the west side of the building. These outlets were recently replaced and are in good condition.
- There is one exterior site light in the south parking area. This light is original.
- Underground electrical lines run to each electrical component. Lines are original.

Vehicle outlet

- Repair as needed.

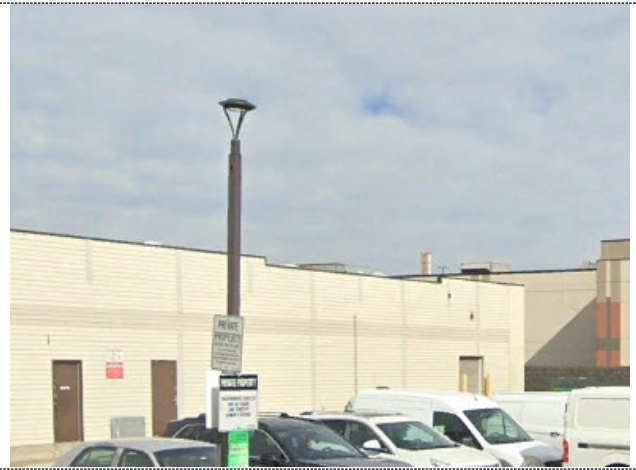
Site light

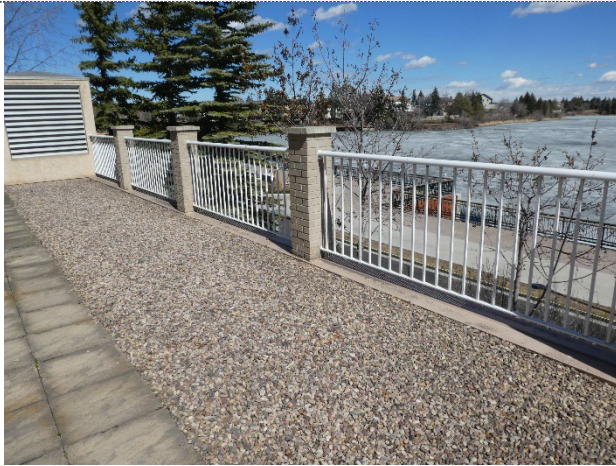
Railings & brick pillars

| <b>Fencing &amp; Exterior Stairs – continued</b> | | |
|---|---|---|
| <ul style="list-style-type: none"> <li>– Funds are allocated every 10 years to repair/paint railings &amp; repair brick pillars. Repair/refurbish as needed.</li> <li>– Funds are allocated every 10 years to refurbish metal stairs.</li> </ul> | | |

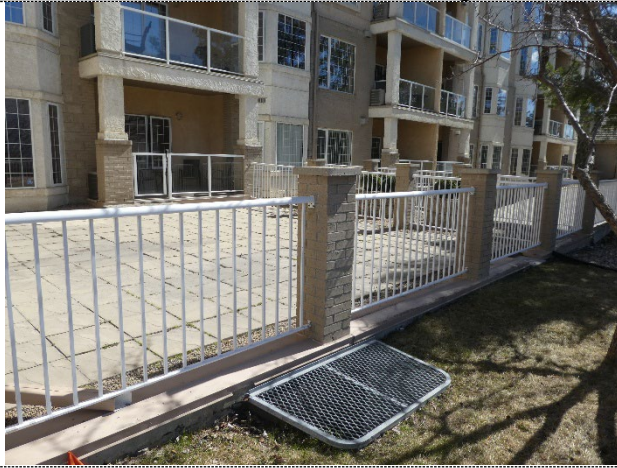
Railings & pillars
