## RESERVE FUND STUDY REPORT

# ***SIERRAS ON THE LAKE CONDOMINIUM CORPORATION***

CONDOMINIUM PLAN No. 022 6881

MAY 2026  
FINAL

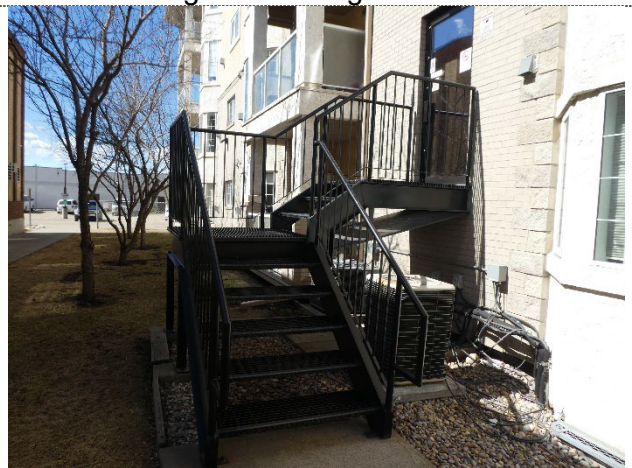
South stairs

| <b>Fencing &amp; Exterior Stairs – continued</b> | | |
|---|---|---|
| <ul style="list-style-type: none"> <li>– Funds are allocated every 10 years to repair/paint railings &amp; repair brick pillars. Repair/refurbish as needed.</li> <li>– Funds are allocated every 10 years to refurbish metal stairs.</li> </ul> | | |

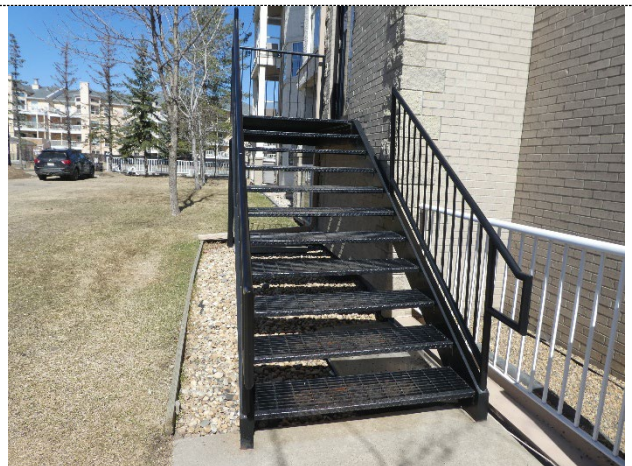
West stairs

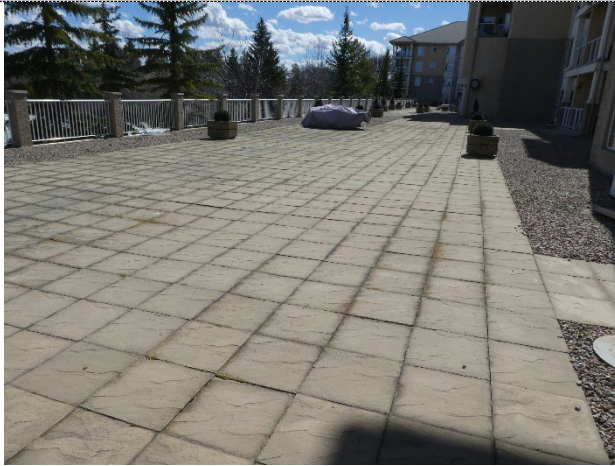
Back plaza deck

- Monitor parkade ceiling for any leaking.
- Parkade membrane / plaza deck can be replaced in a phased program and should be started when leaking occurs.

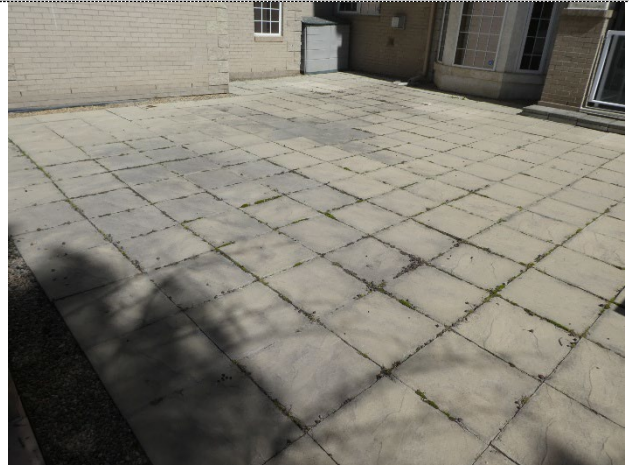
Front plaza deck

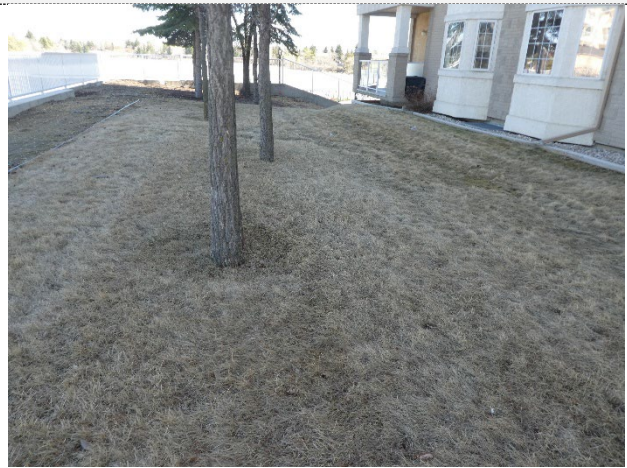
Landscaping along north side of the building

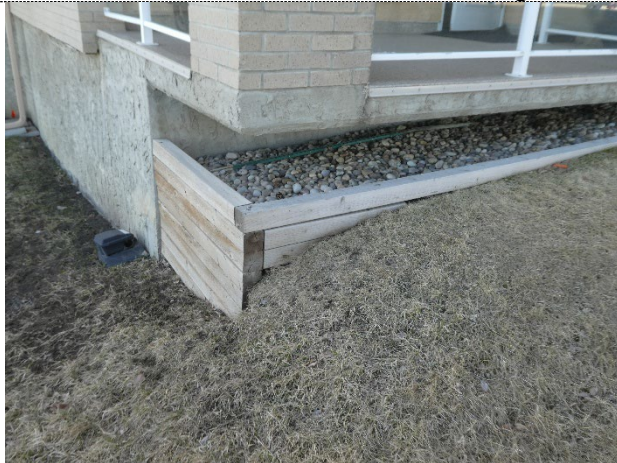
Small wood planter box with stone

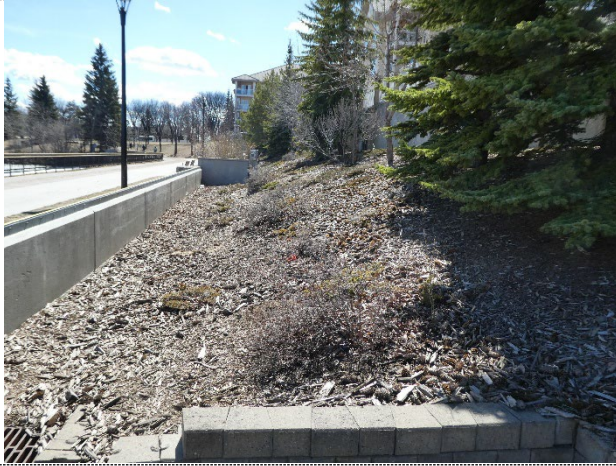
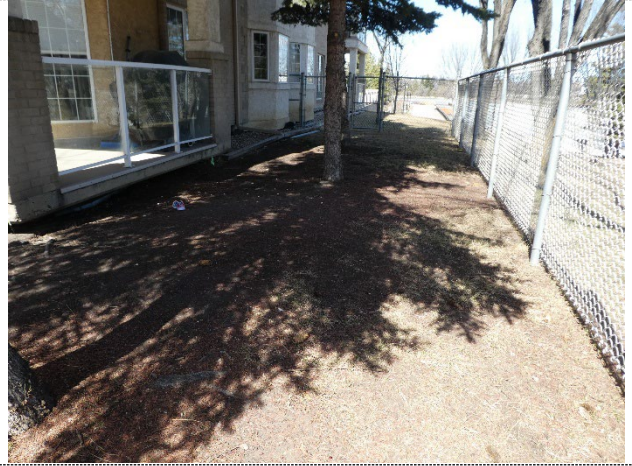
Landscaping on east side of building

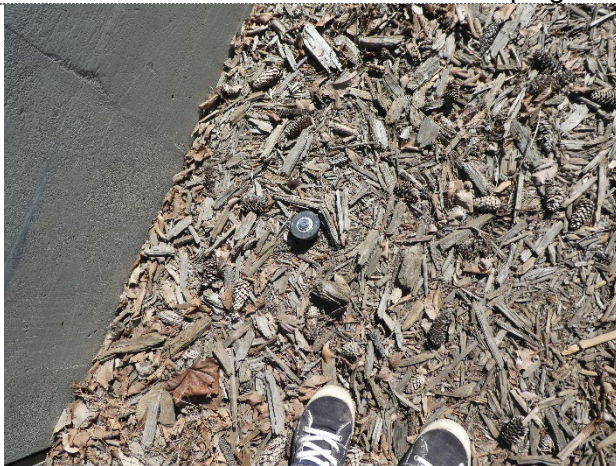
Mulch & sprinkler head

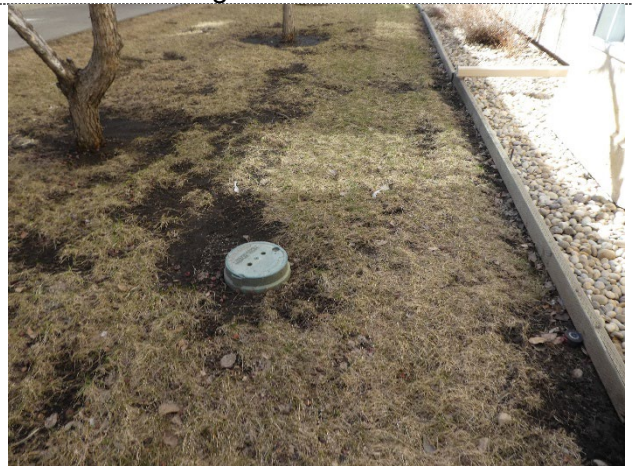
Sprinkler controls

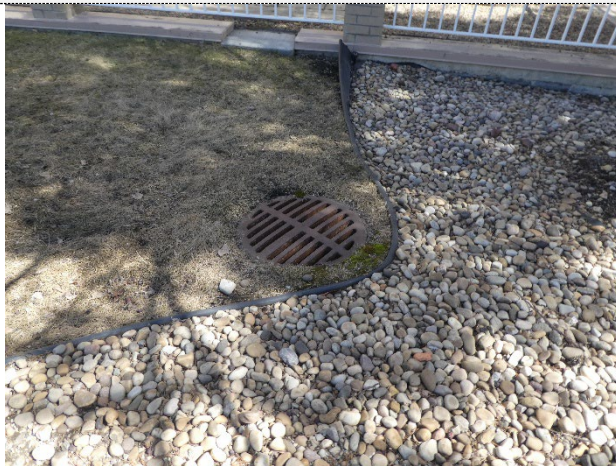
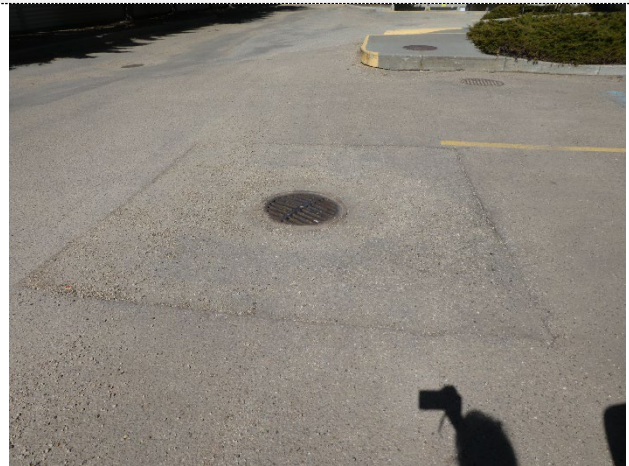
#### Drains

- Underground water and sewer systems cannot be inspected for this report. The corporation is responsible for all underground services under the common property.
- Fire hydrants will require flushing occasionally. Valves will require replacement over time. Fire hydrant was replaced in the 2025 fiscal year.
- Drains are installed in the landscaping & roadway.

- Money is budgeted to repair damaged underground water & sewer systems as needed.
