RV Inspection Report

2020 Pleasure Way Tofino

RV VIN: VINOFRV4YOU528763 **Inspection Date:** 5/13/2024

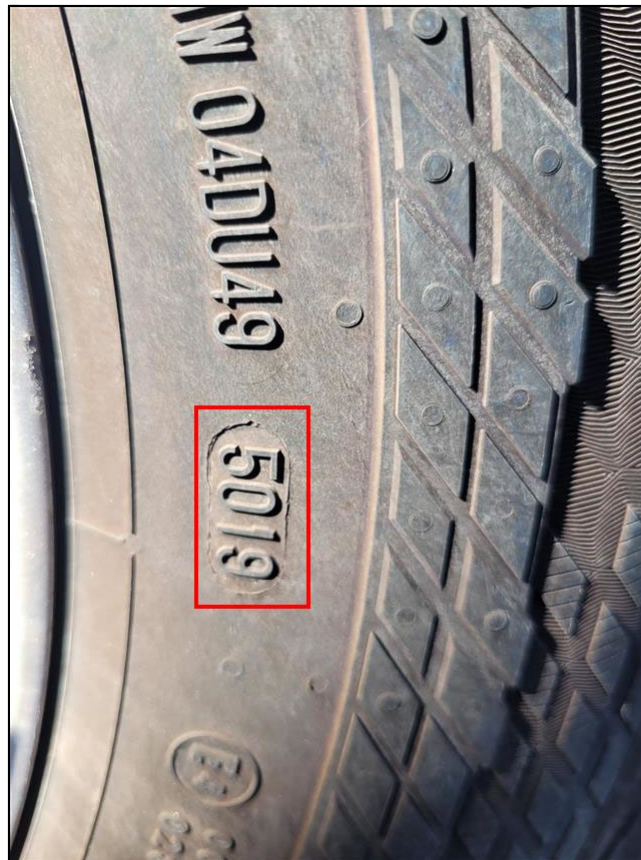
DOT Date Code

The DOT date code is four digits at the end of the DOT manufactures code. The first two digits indicate the week of the year and the last two digits are the last two digits of the year. This tire was manufactured in the 50th Week of 2019.

The air pressure for this tire was 65 PSI and the recommended pressure is 65 PSI. It is important to check tire pressures prior to and daily while traveling.

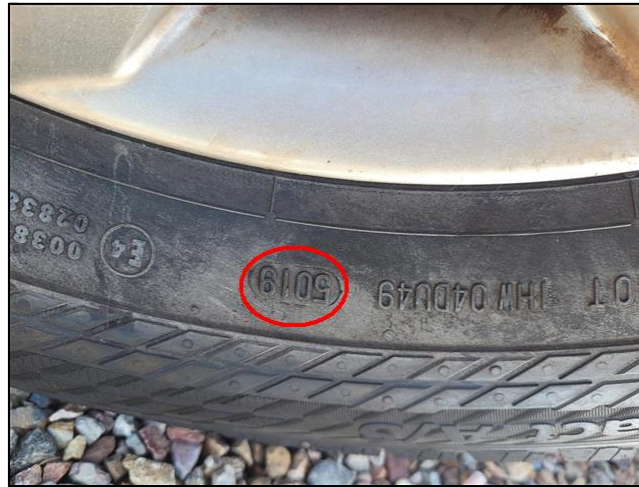
DOT Date Code

The DOT date code is four digits at the end of the DOT manufactures code. The first two digits indicate the week of the year and the last two digits are the last two digits of the year. This tire was manufactured in the 50th Week of 2019.

The air pressure for this tire was 65 PSI and the recommended pressure is 65 PSI. It is important to check tire pressures prior to and daily while traveling.

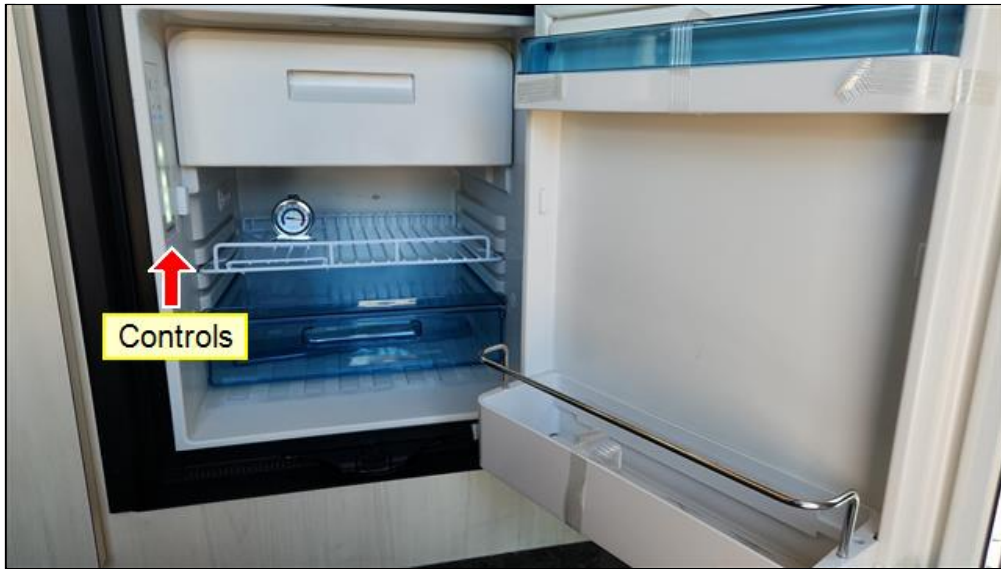
Controls

The refrigerator was not turned on prior to the start of the inspection. The refrigerator was run during the course of the inspection and only started to cool. The Refrigerator and Freezer did not reach a safe cooling temperature prior to the end of the inspection. RV refrigerators require at least 12 hours minimum to reach a food safe temperature. It is recommended that the refrigerator be turned on to AC electric operation and be given a minimum of 12 hours to cool and then retest.

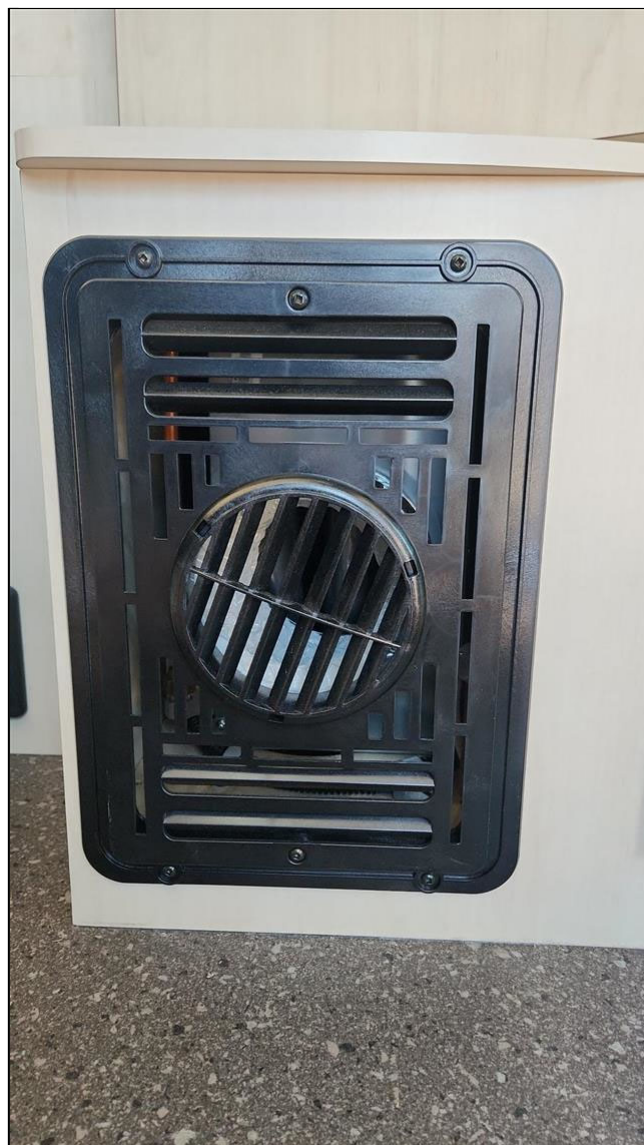
Furnace

Comments: Not Inspected

Unable to turn on due to current ambient temperature.

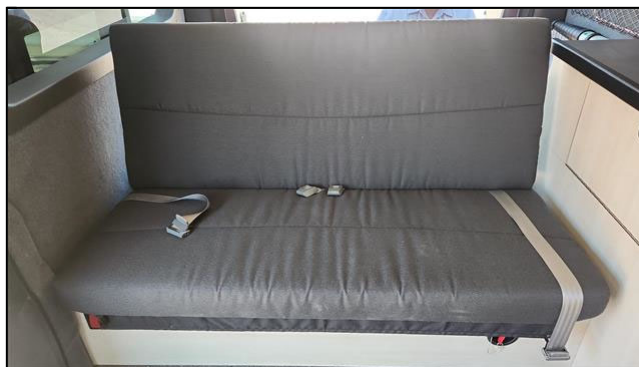
Sleeper Sofa

Comments: Acceptable

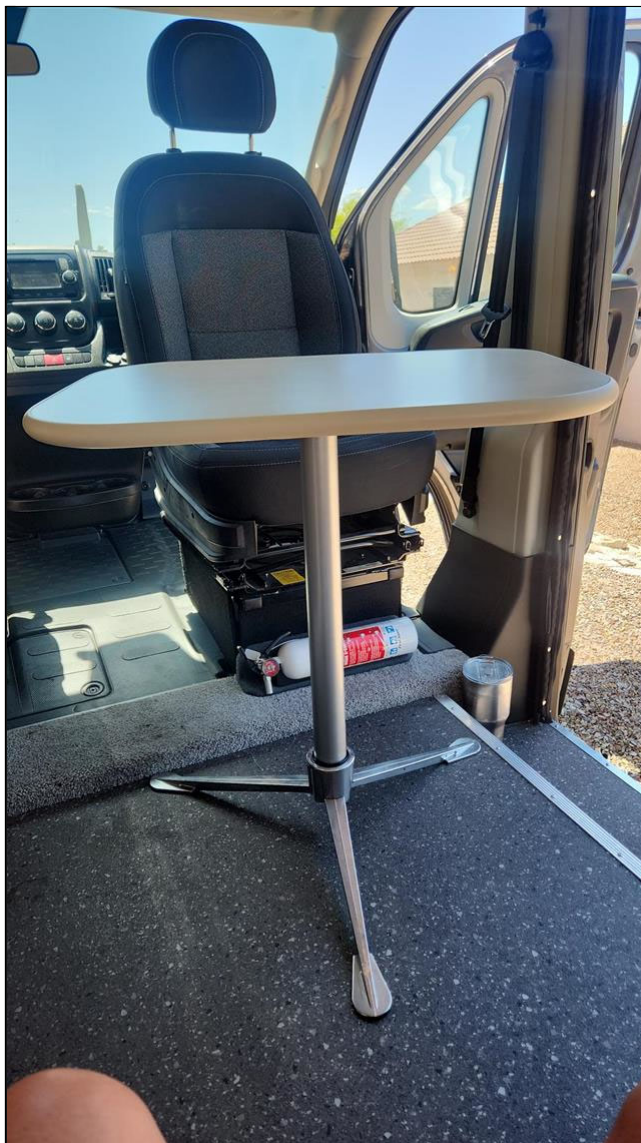
Interior Table- 3 pieces

Comments: Acceptable

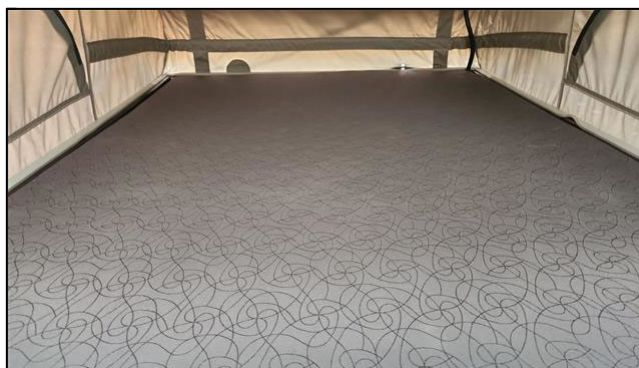
Mattress

Comments: Acceptable

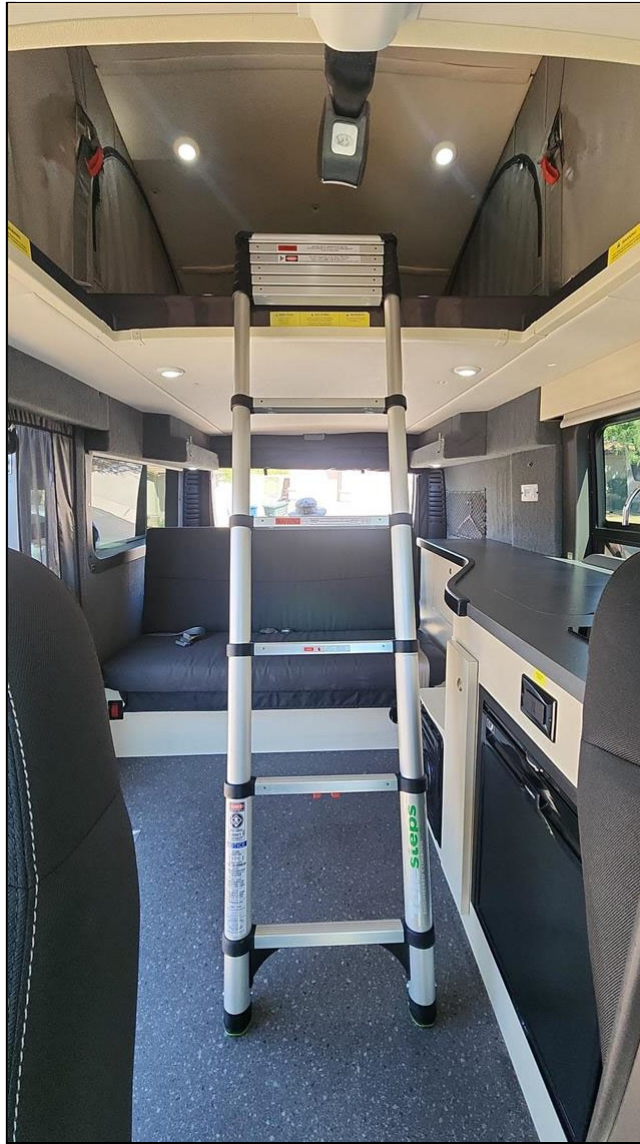
Ladder

Comments: Acceptable
