INSPECTION REPORT

For the Property at:
4321 NEW HOME BLVD.
5 COUNTIES OF THE ARROWHEAD, MN

Prepared for: JANE & JOHN HOMEBUYER
Inspection Date: Friday, June 18, 2021
Prepared by: Kyle Hotchkiss

RE: Report No. 1003, v.2
4321 New Home Blvd.
5 Counties of the Arrowhead, MN

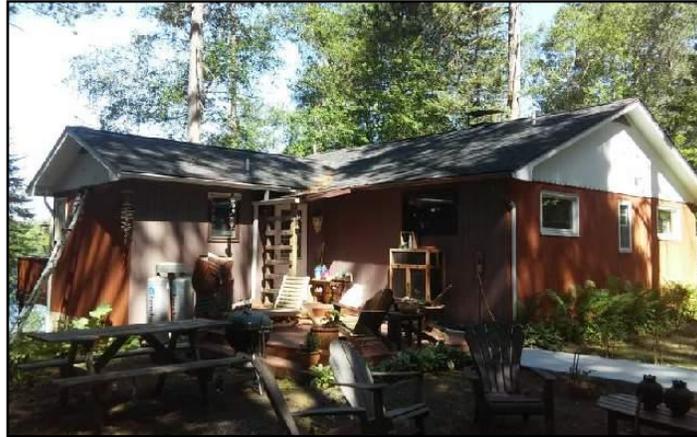
11. Missing

2. Condition: • Missing

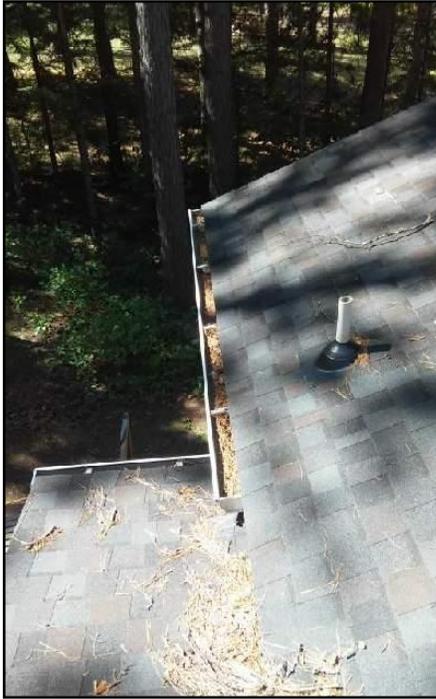
4. Condition: • Dirty/debris

12. Dirty/debris

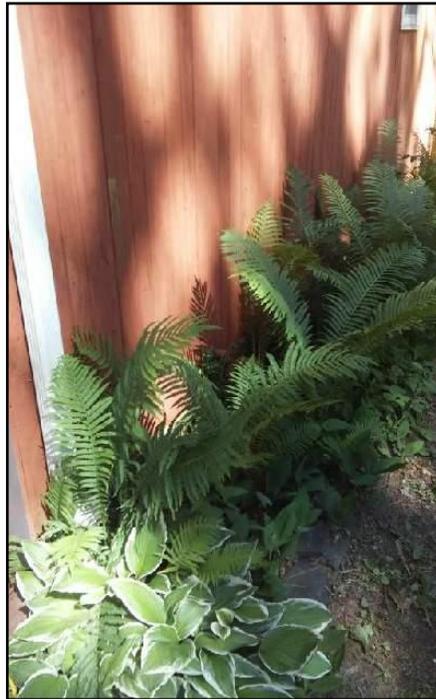
5. Condition: • [Discharge too close to building](#)

Implication(s): Chance of water damage to structure, finishes and contents

15. Discharge too close to building

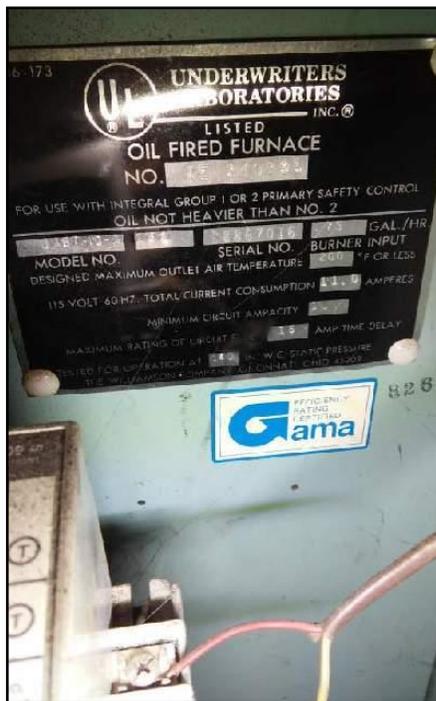
34.

Furnace manufacturer: • Williamson

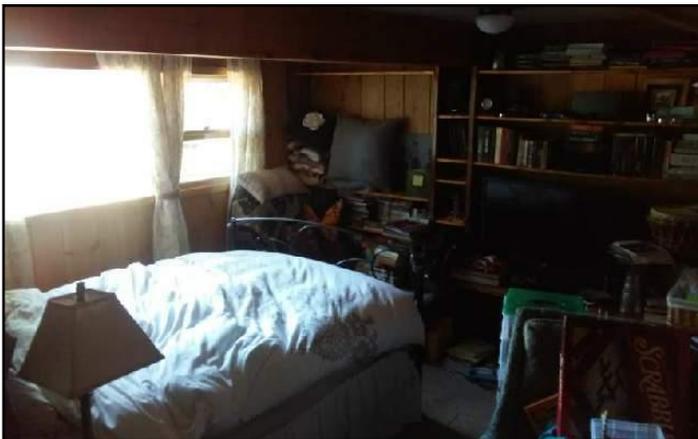
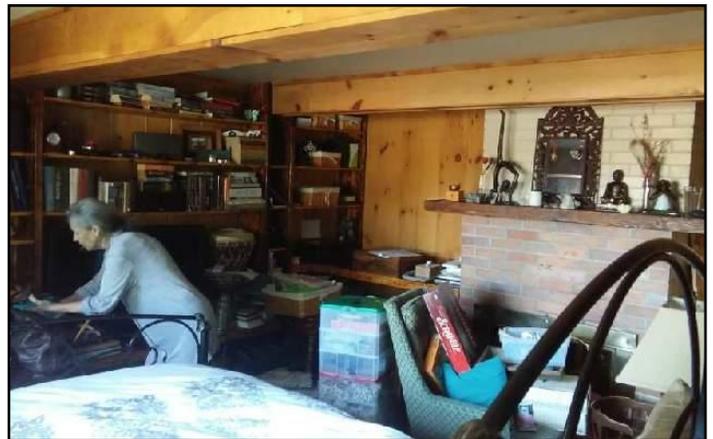
26. Condition: • Reference
Location: Northwest Basement Bedroom

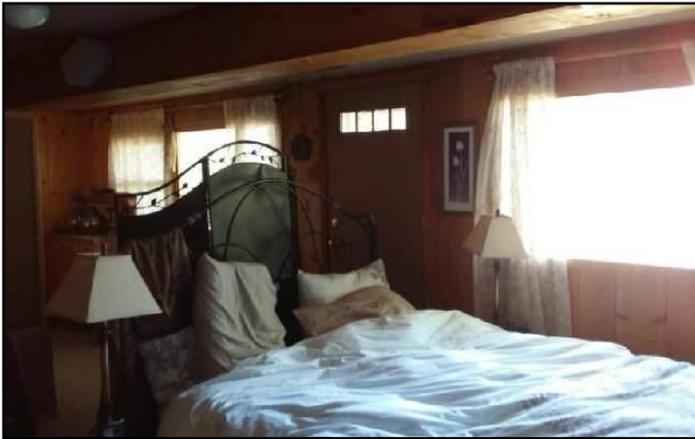
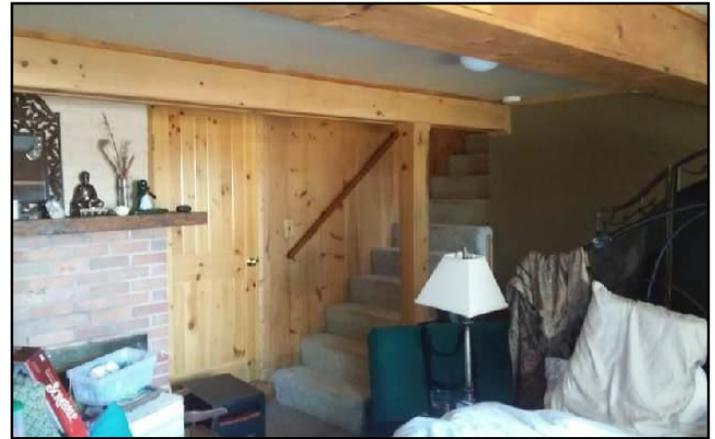
27. Condition: • [Stains](#)

Implication(s): Chance of water damage to structure, finishes and contents

73. Stains

74. Stains

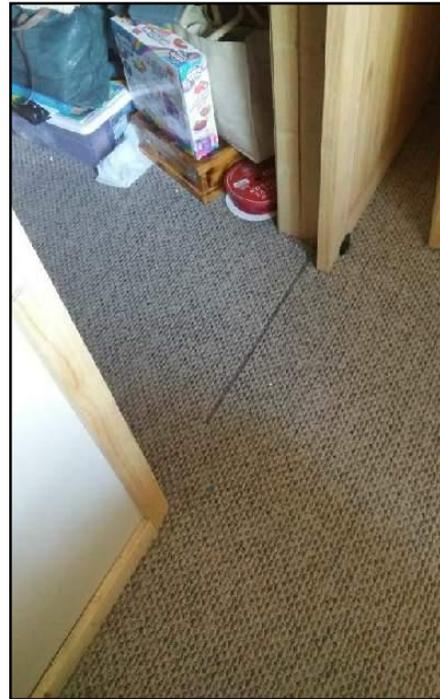
28. Condition: • Damaged
Location: Basement Bedroom
Task: Replace
Time: Discretionary
