PROPERTY CONDITION REPORT

Concerning: 6575 Rambler Ct, Spring, TX 77386
(Address of Inspected Property)

By: Matthew Brading, Lic #TREC # 22654 04/01/2021
(Name of Inspector) (Date)

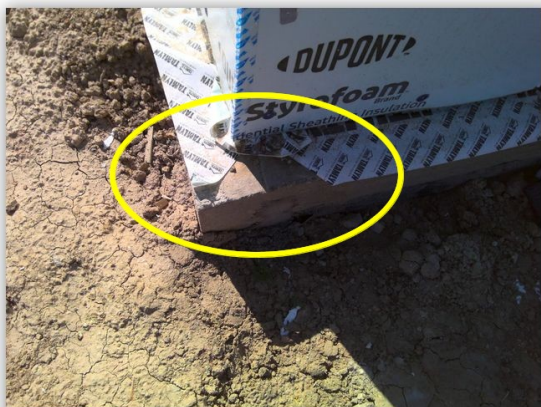
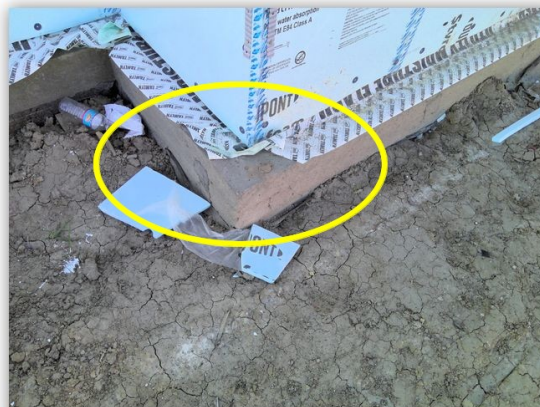
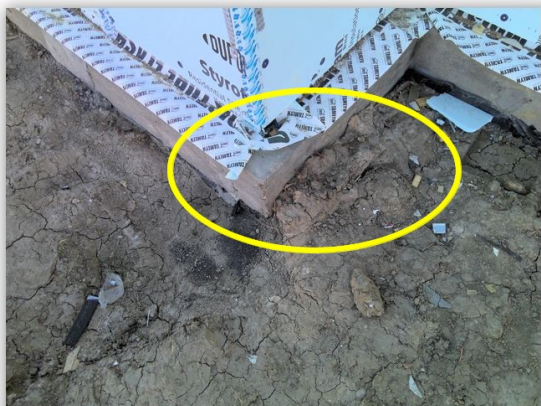
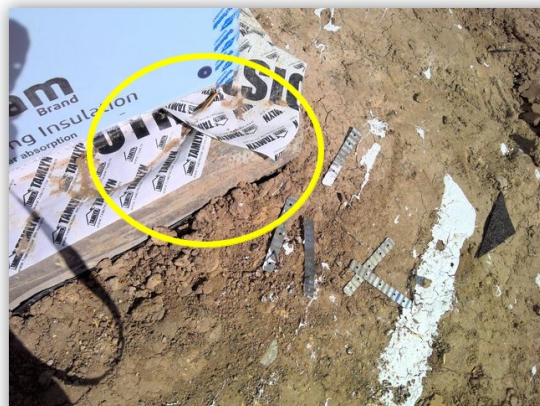
- The poly bond breaker / flashing detail for the foundation veneer ledge does not properly cover the veneer edge on the front and back sides of the structure.

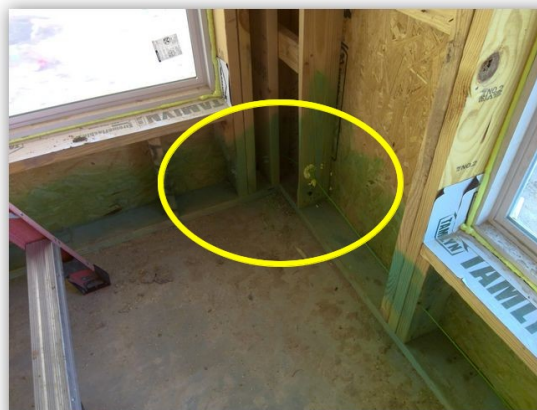
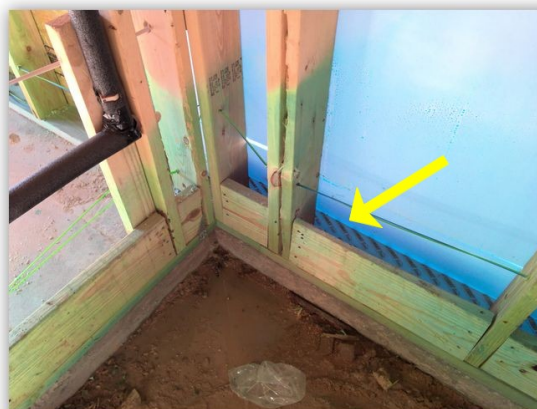
- There are not enough anchor bolts or straps in place in the hall bathroom, dining room, breakfast area and master bedroom closet. Under current code requirements bottom plates shall be anchored to the foundation with anchor bolts or strap spaced a maximum of 6 feet on center. There should be a minimum of two bolts or straps per plate section with one bolt or strap located not more than 12 inches or less than seven bolt diameters from each end of the plate section.

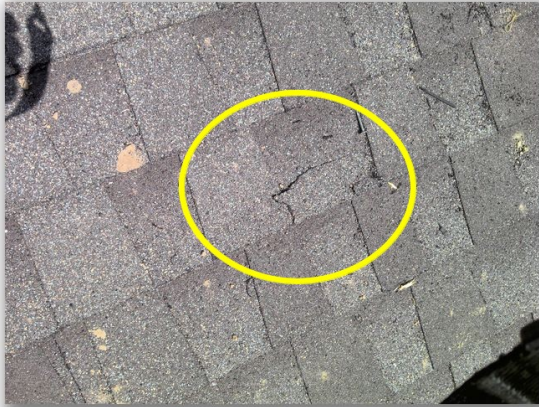
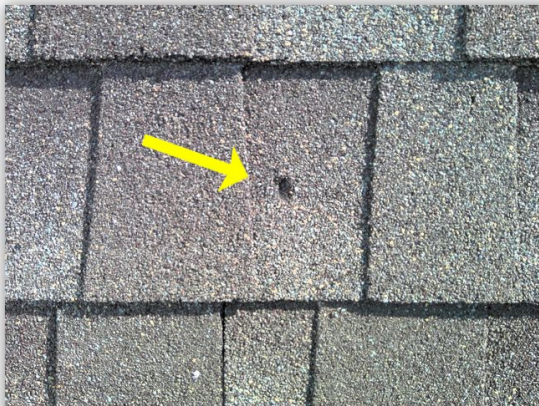
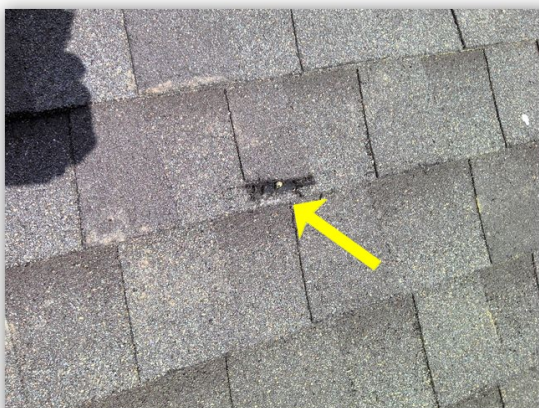
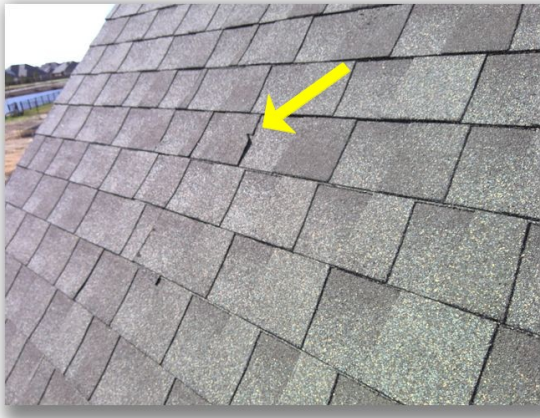
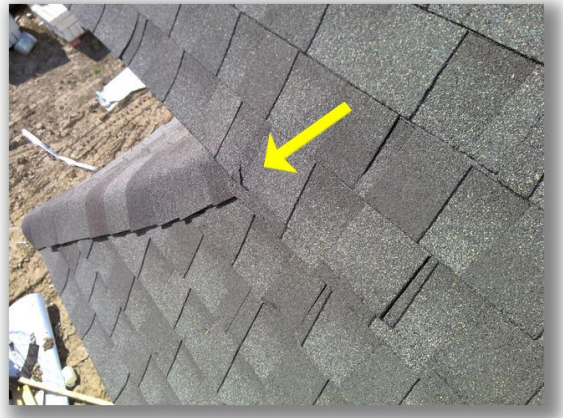
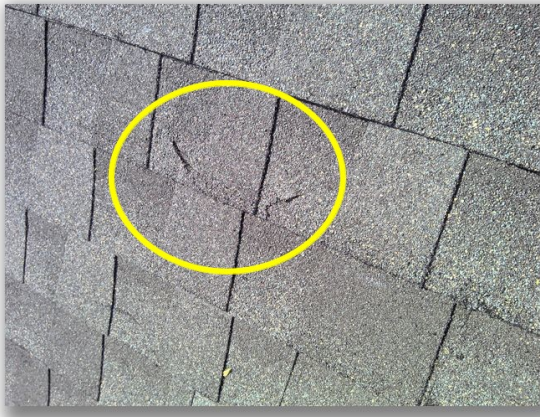
- Damaged shingles were observed on the front side of the roof structure.

Note: When D (**D=Deficient**) is marked. It is recommended that all of the roofing material and its components be fully evaluated by a Qualified Roofing Specialist, prior to the expiration of any time limitations such as option or warranty periods.

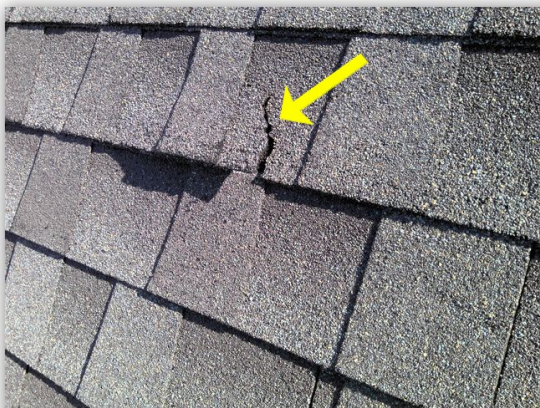
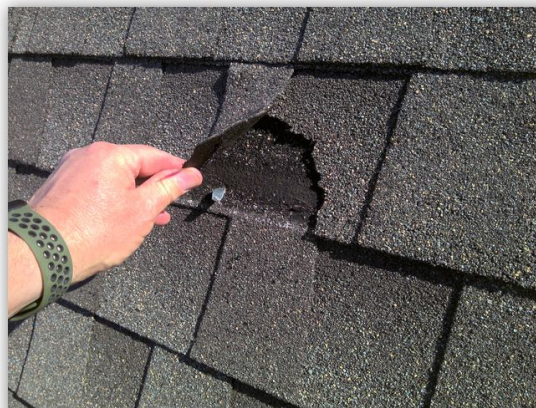
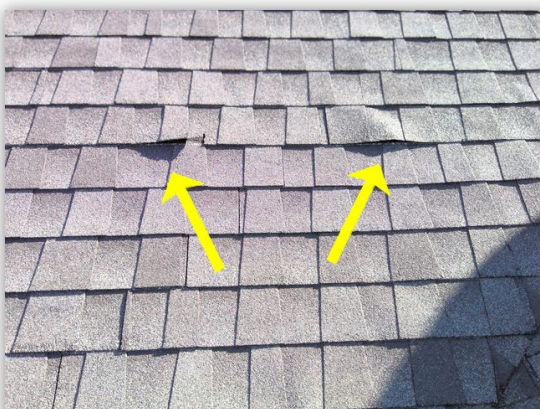
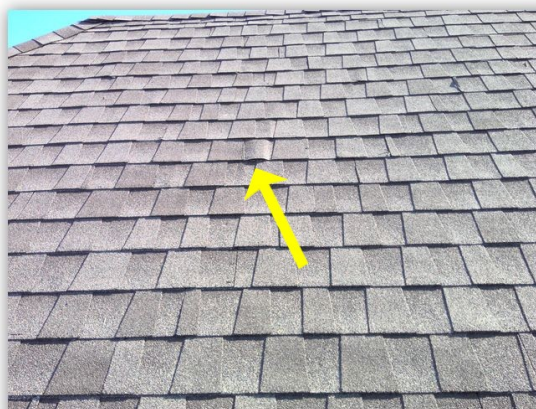
- Damaged shingles were observed on the back side of the roof structure.
- One or more of the shingles were observed to be lifting on the back side of the roof structure.

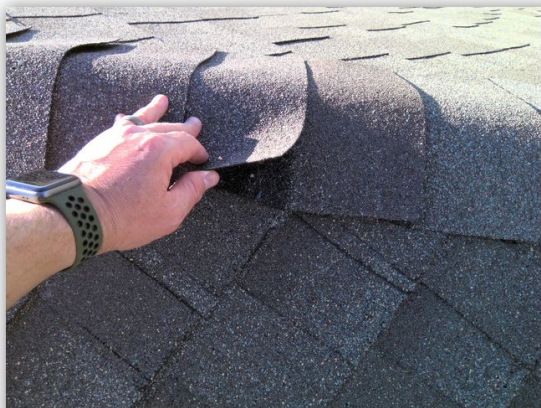
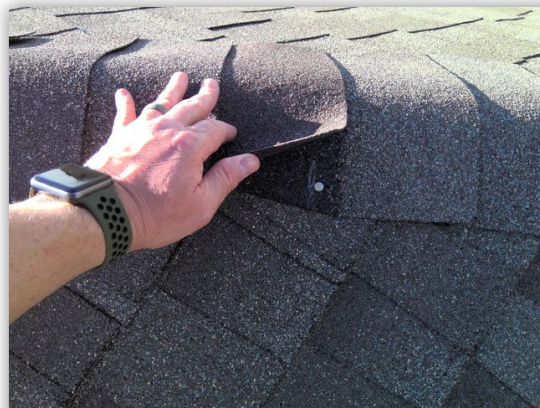
- Poorly adhered ridge cap shingles observed at the back side of the roof structure.

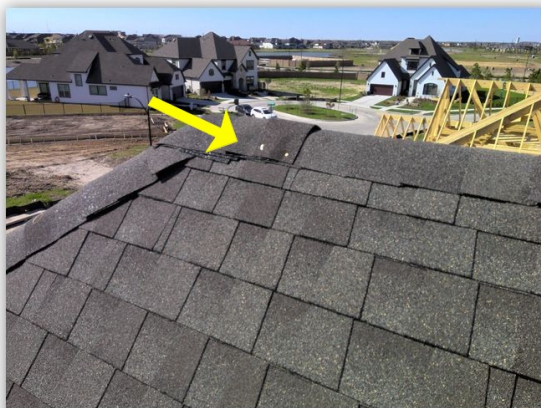
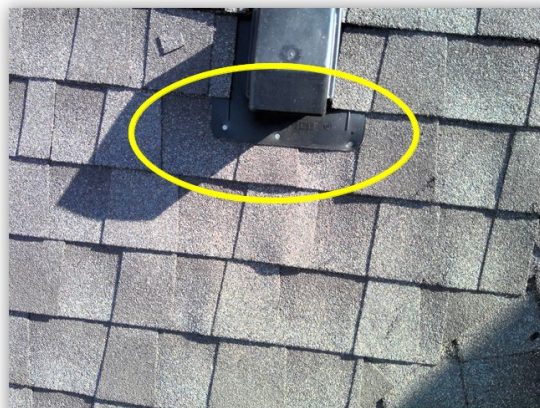
- **Note:** Roof fasteners (nails and/or staples) were observed to be exposed and should be properly sealed at the ridge caps and flashing areas.

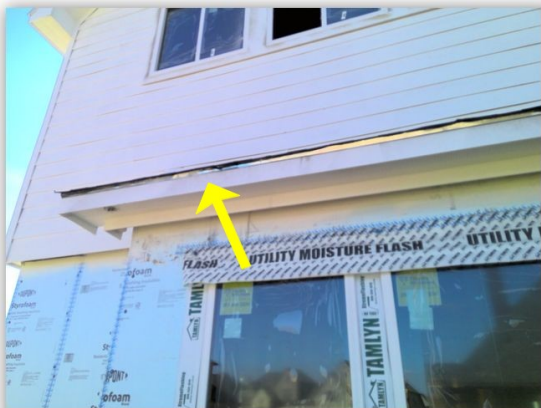
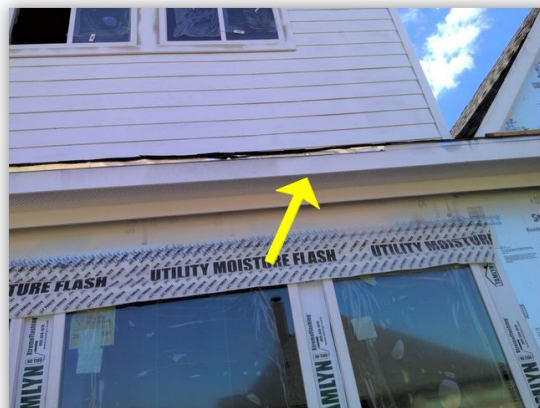
- Poorly installed drip edge flashing observed at the back side of the structure.

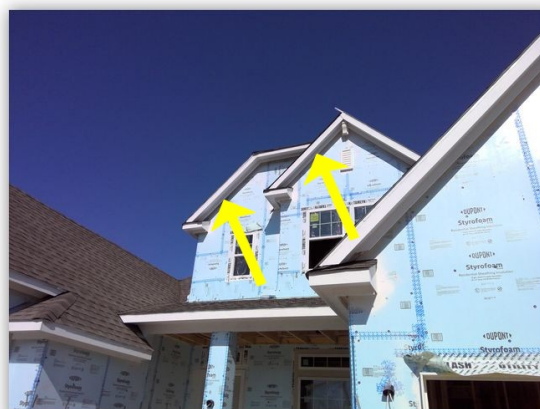
- Missing drip edge flashing observed at the front and back sides of the structure.

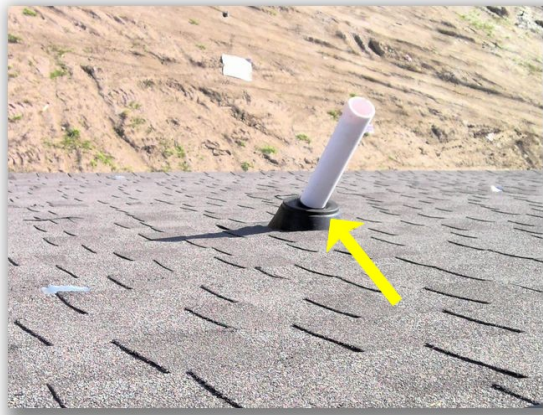
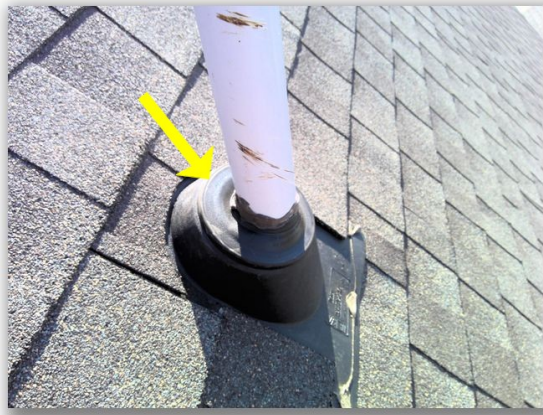
- One or more of the roof level plumbing vent stack flashing details are buckled downward around the plumbing stack. This condition could allow water penetration at this point and corrective measures are recommended.

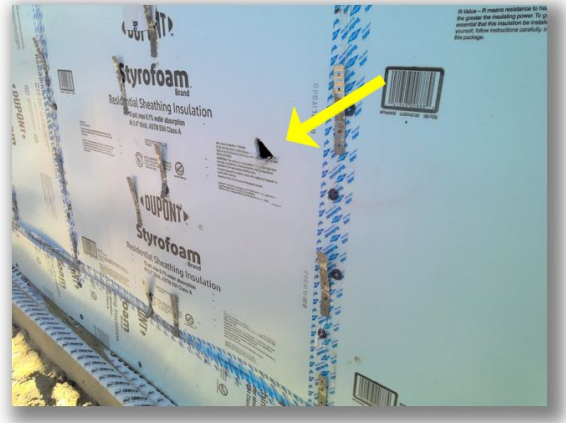
- The holes and/or openings (utility, doors, windows, etc.) in the exterior sheathing / weather barrier should be properly sealed (mastic or tape) on the right and left sides of the structure.

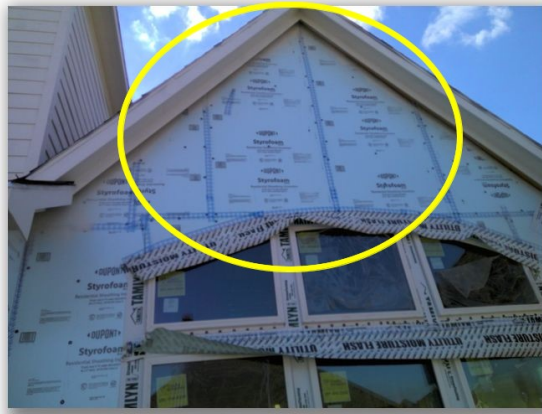
Missing sheathing and/or blocking observed at the front and back sides of the structure.

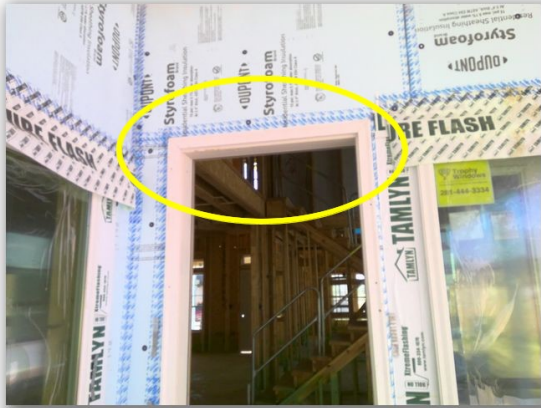
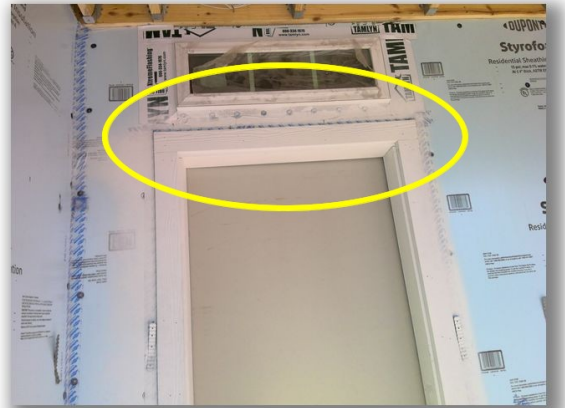
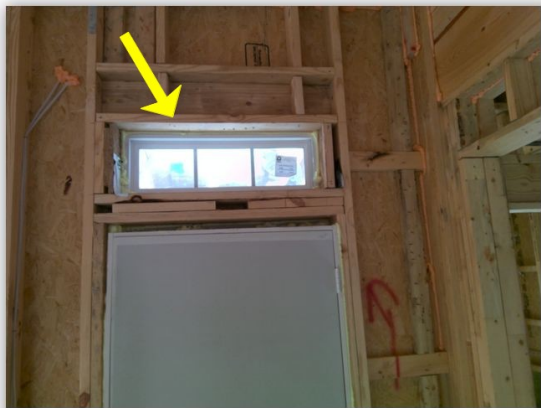
- There is no visible through wall "head" flashing details install above the exterior doors on the front and back sides of the structure. Under current building standards, through wall "head" flashing is required to be installed to help prevent water intrusion from occurring at this point.

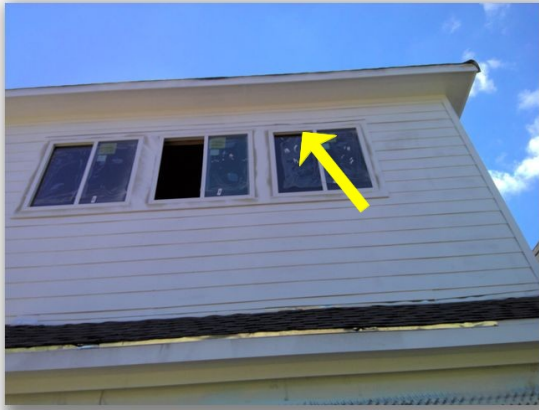
Poorly installed Z flashing observed over the windows in att the back of the structure.

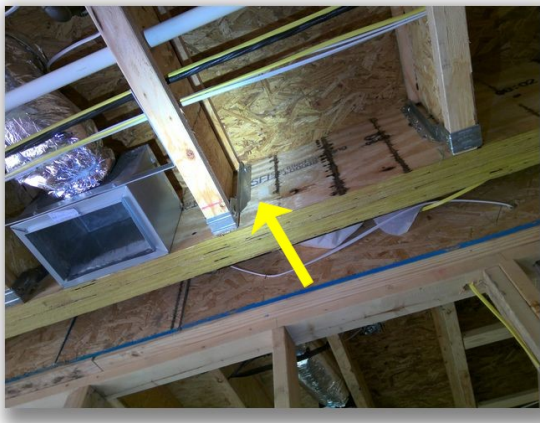
- One or more joist hanger(s) do not have enough fasteners (nails) installed in the laundry room.

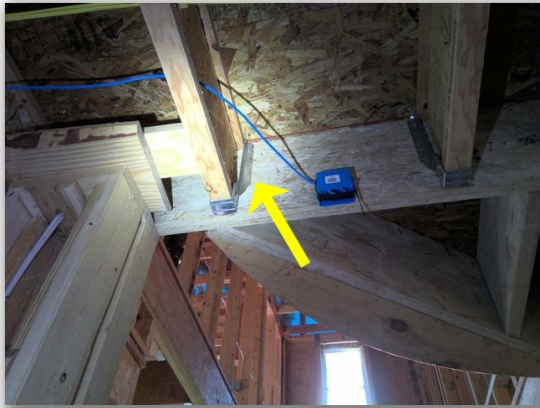
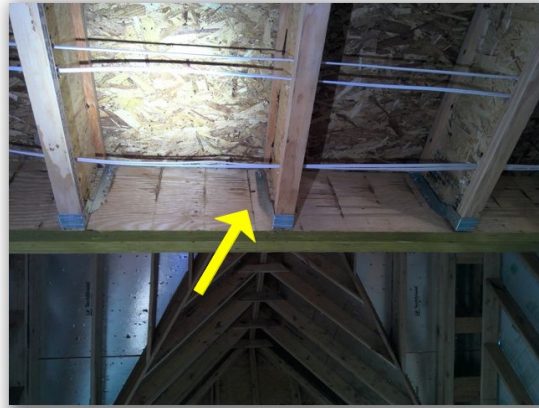
- One or more joist hanger(s) do not have enough fasteners (nails) installed in the kitchen.

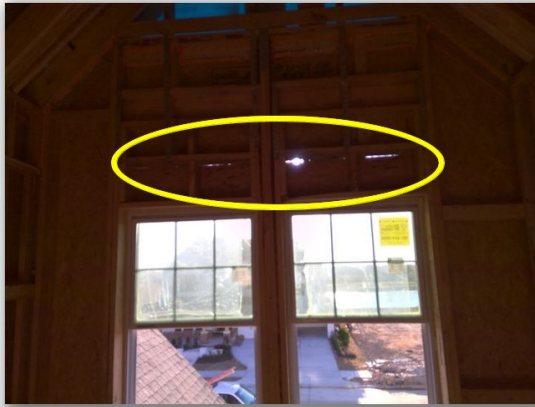
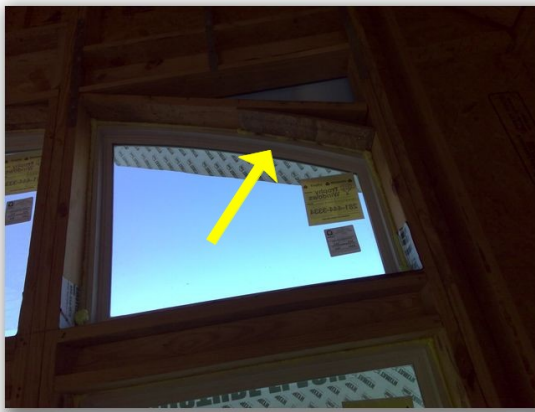
- Missing or gaps in the insulating foam were observed in the upstairs front middle bedroom.
- Missing or gaps in the insulating foam were observed in the living room.

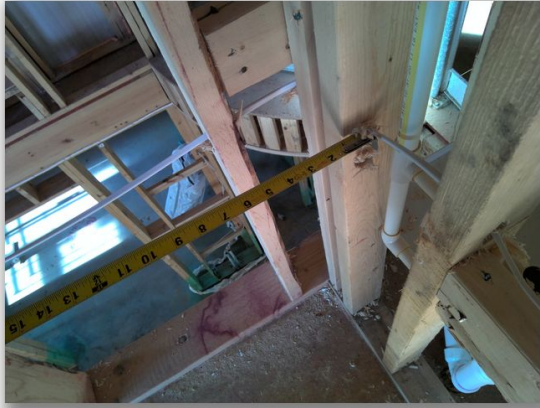
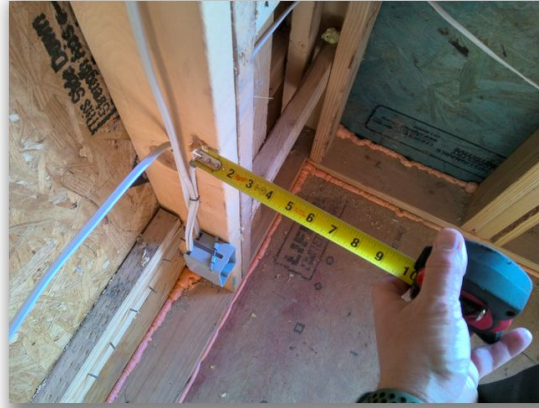
- Striker plates are needed to help protect the electrical branch circuit wiring from fastener (nail or screw) damage in various locations throughout the structure. Bored holes in framing members for wiring shall be located not less than 1 ¼ inches from the edge of the framing member or shall be protected with a minimum 0.0625-inch steel plate or sleeve, a listed steel plate or other physical protection.
- Striker plates are needed to help protect the electrical branch circuit wiring from fastener (nail or screw) damage in the upstairs front middle bedroom.

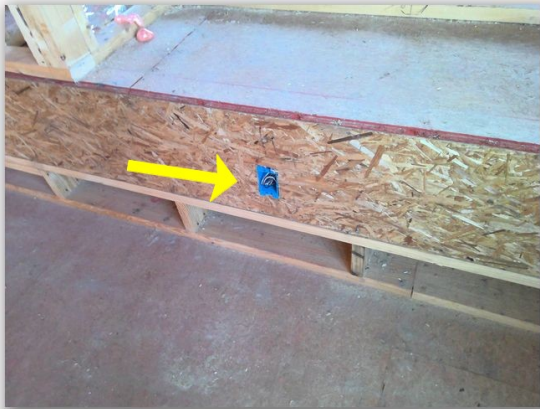
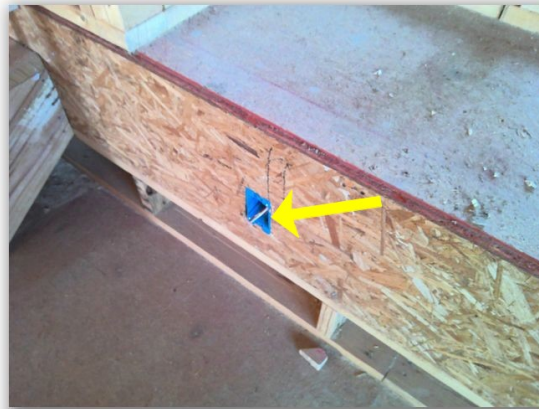
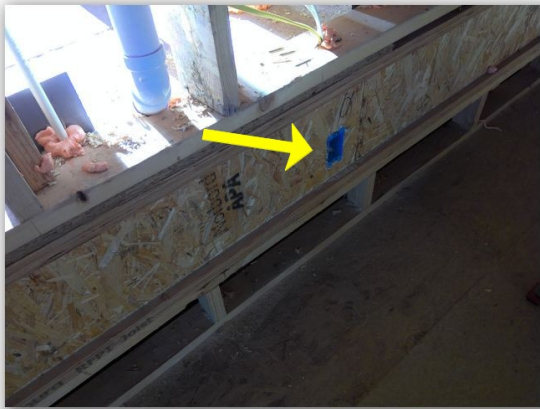
- The electrical junction box does not properly set out 1/2-inch from the wall stud in the gameroom.

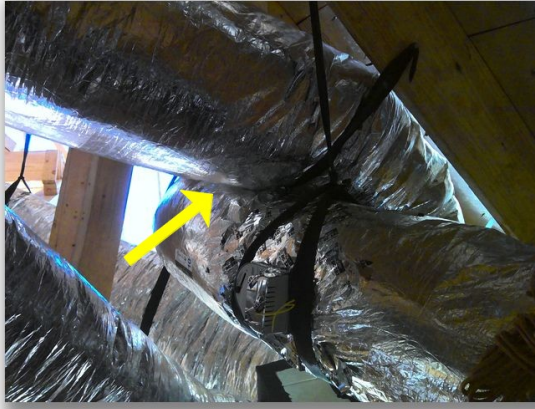
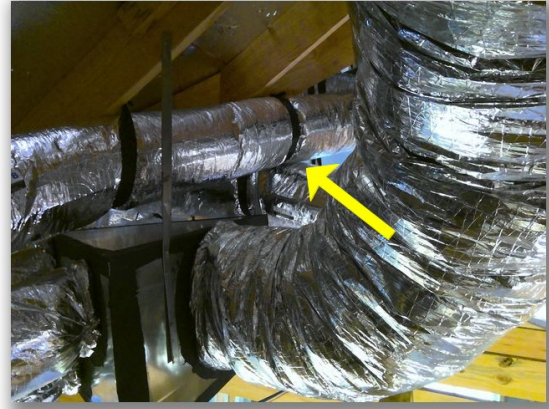
- Ducts that are touching should be separated by insulation to help prevent condensation.

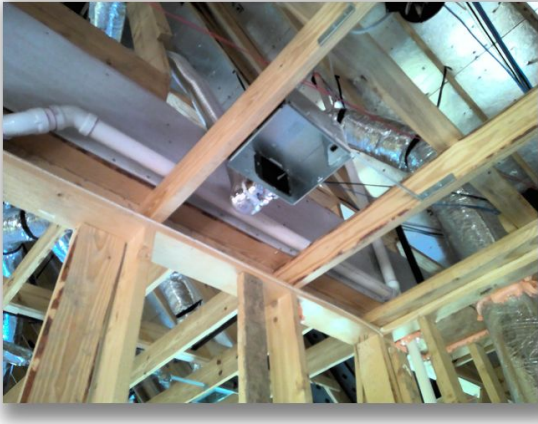
- No mechanical exhaust fan was observed in the laundry room area.

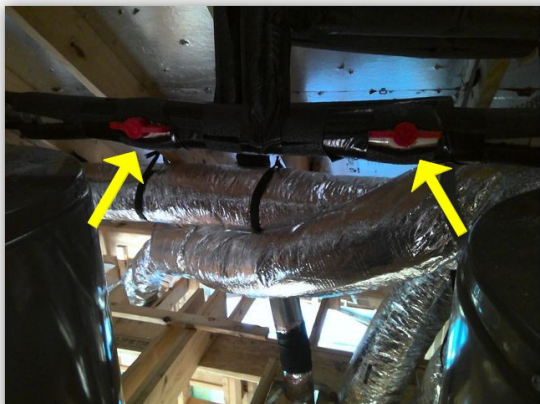
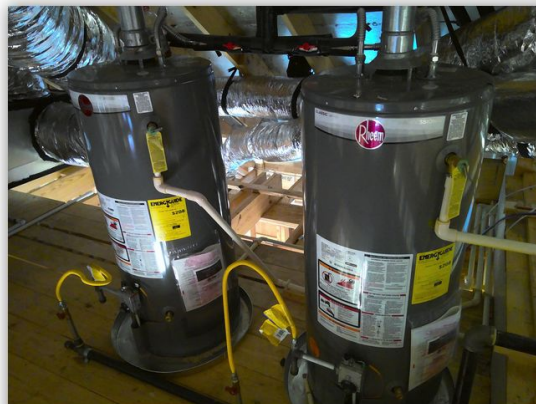
Note: Although not considered deficient, CPVC valves used at the water heater have a history of failure and replacement with a metal valve is recommended.
